Barling Magna Parish Council Tree Condition Survey Report

Prepared for:
Barling Magna Parish
Council

Date:
17th July 2018

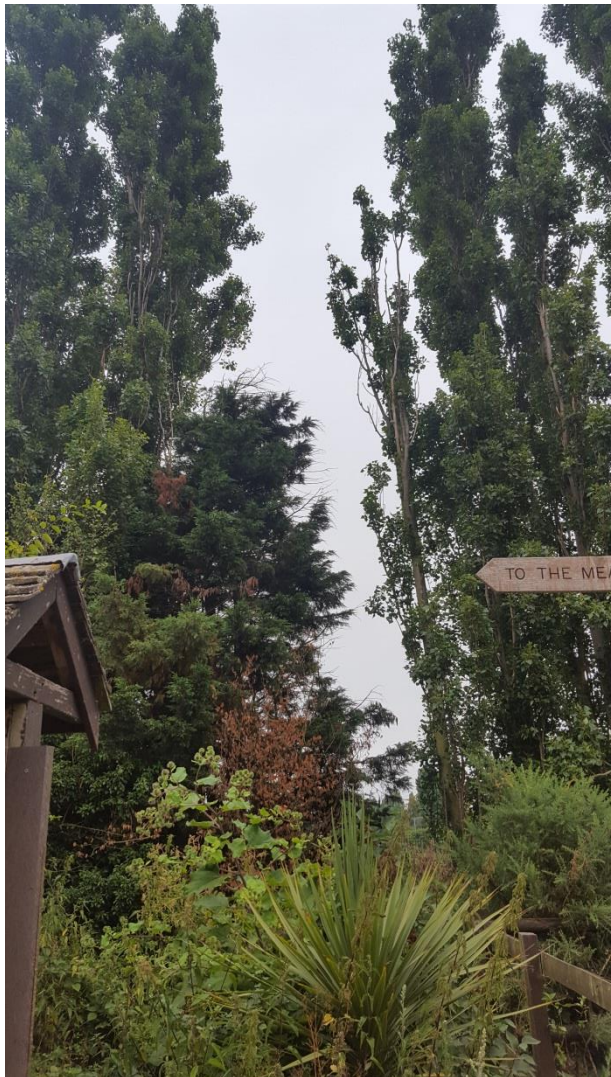
G1. Elm and Poplar that require felling.

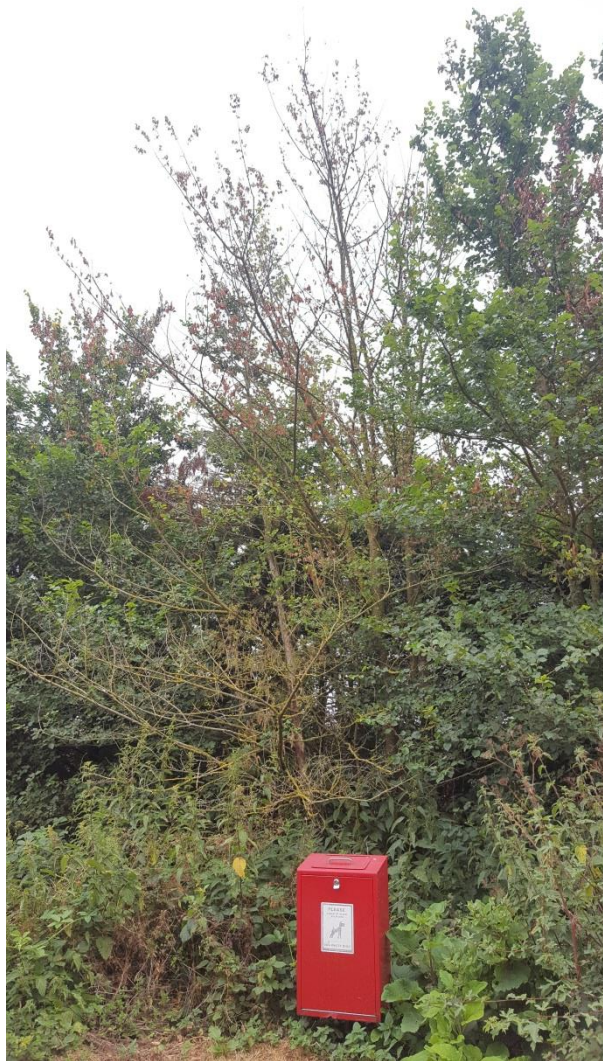
G2. Elm that require a monolith.

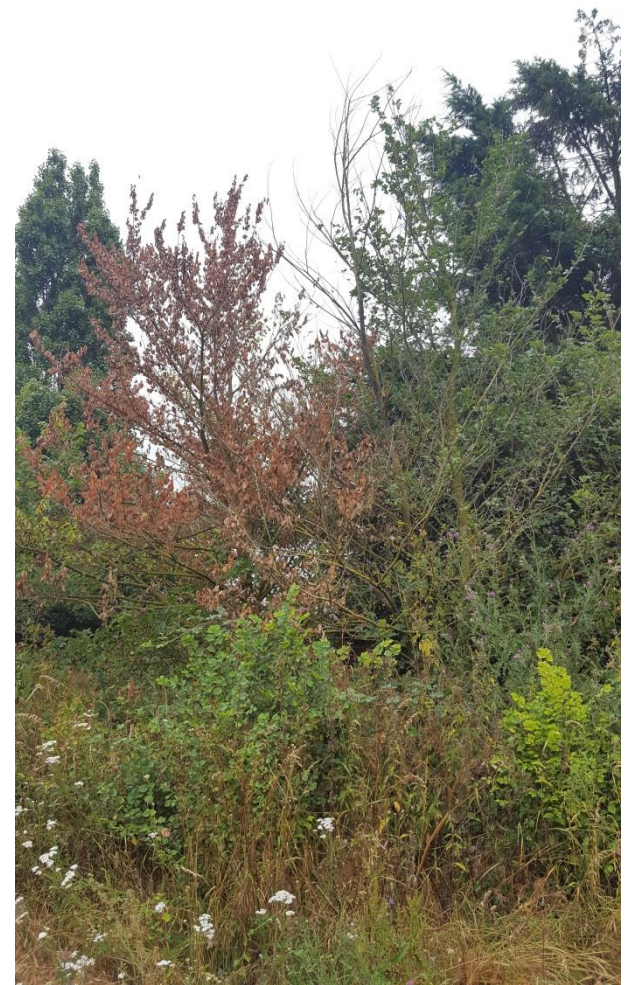
G3. Elm that require a monolith.

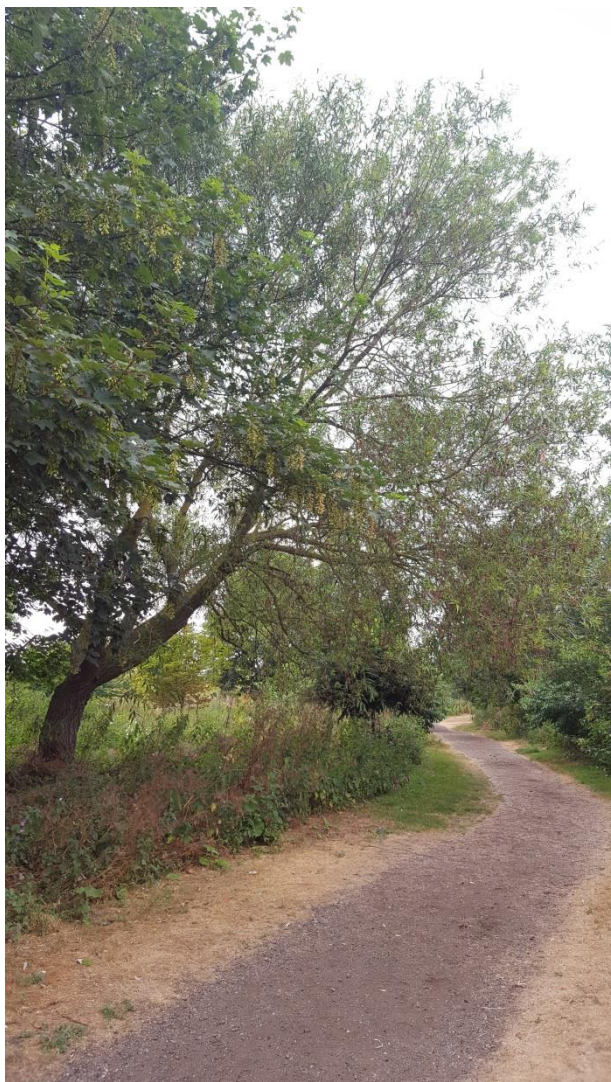
T4. Willow that requires a crown lift over the footpath.

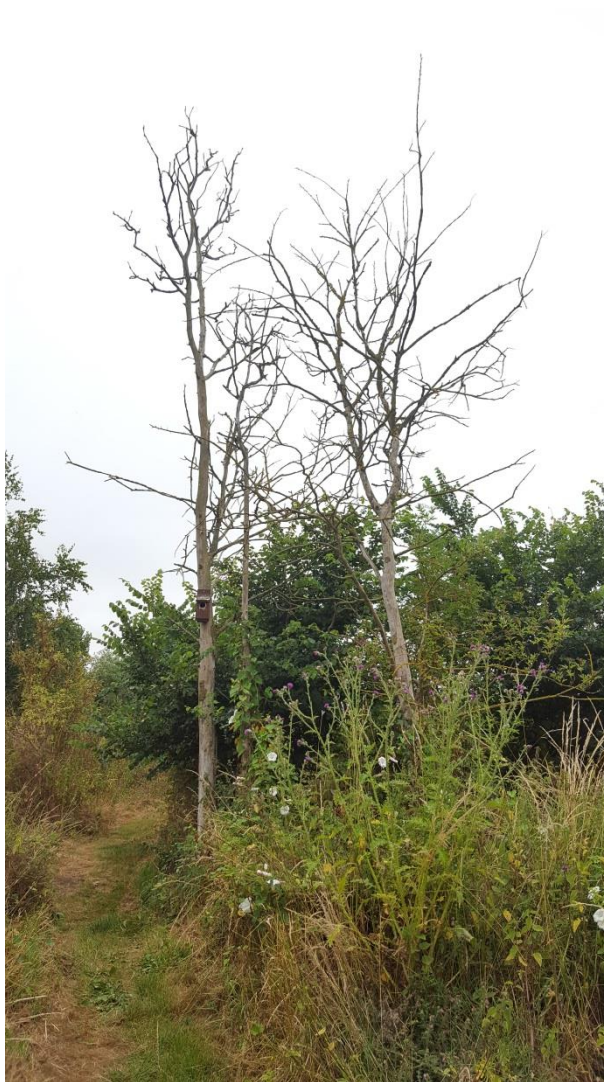
G5. Elm that require a monolith.

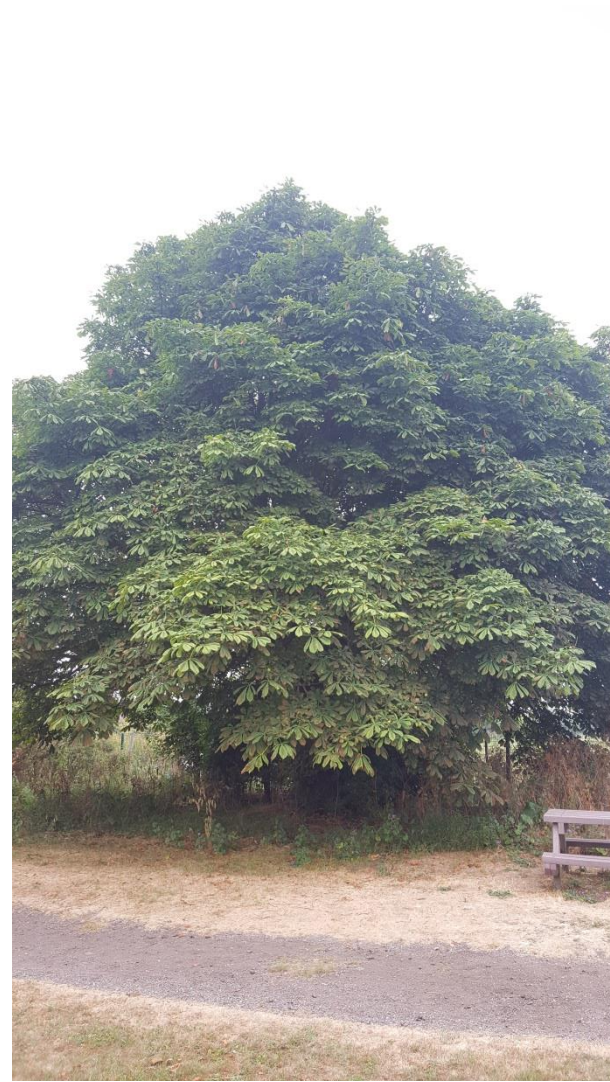
T6	Horse Chestnut <i>Aesculus hippocastanum</i>	14	M	Historical pollard in very good condition. Leaf miner present throughout crown. Early basal decay evident on south-west. Probe could not be inserted and sound test did not reveal any hollowing. Appears to be slow decay.	Monitor on next inspection.	N/A	5
T7	Horse Chestnut <i>Aesculus hippocastanum</i>	10	M	Woodpecker holes within crown on main stem, potential bat roost features. Significant basal cavity to 1.25m, extensive hollowing within. Leaning towards footpath, early dieback in upper crown.	Reduce whole tree in by up to 4m to reduce weight on cavity, retaining ecological features.	4	5
T8	Ash <i>Fraxinus excelsior</i>	12	SM	Large cavity forming between unions in base. Sufficient supporting wood present, feature of species so no concern at present.	Monitor on next inspection.	N/A	5

T6. Horse Chestnut that has a basal cavity that requires monitoring.

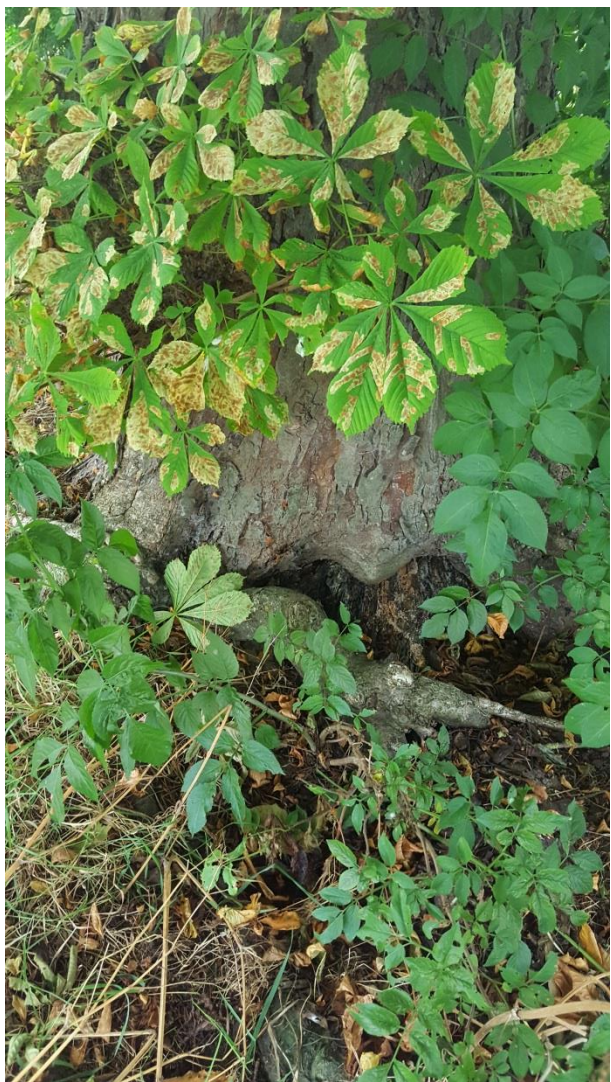
T6. Basal cavity.

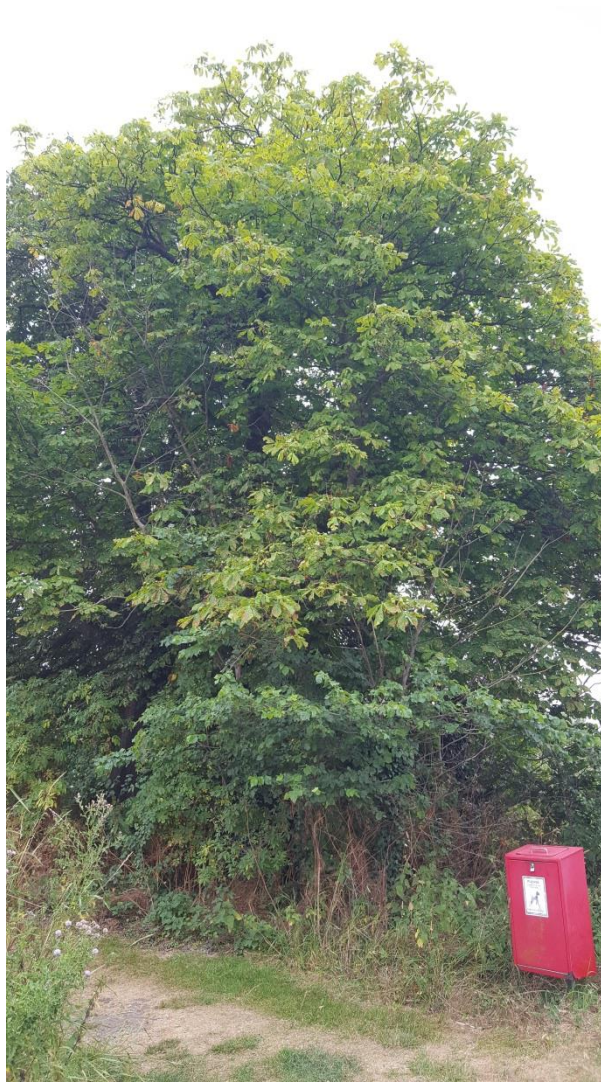
T7. Horse Chestnut that requires a crown reduction.

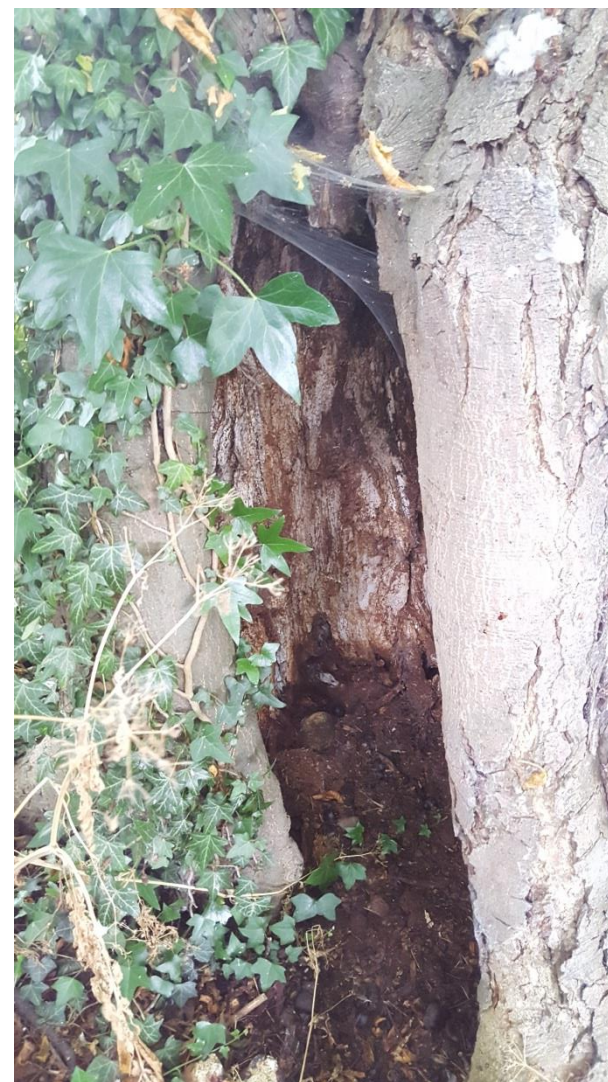
T7. Basal cavity.

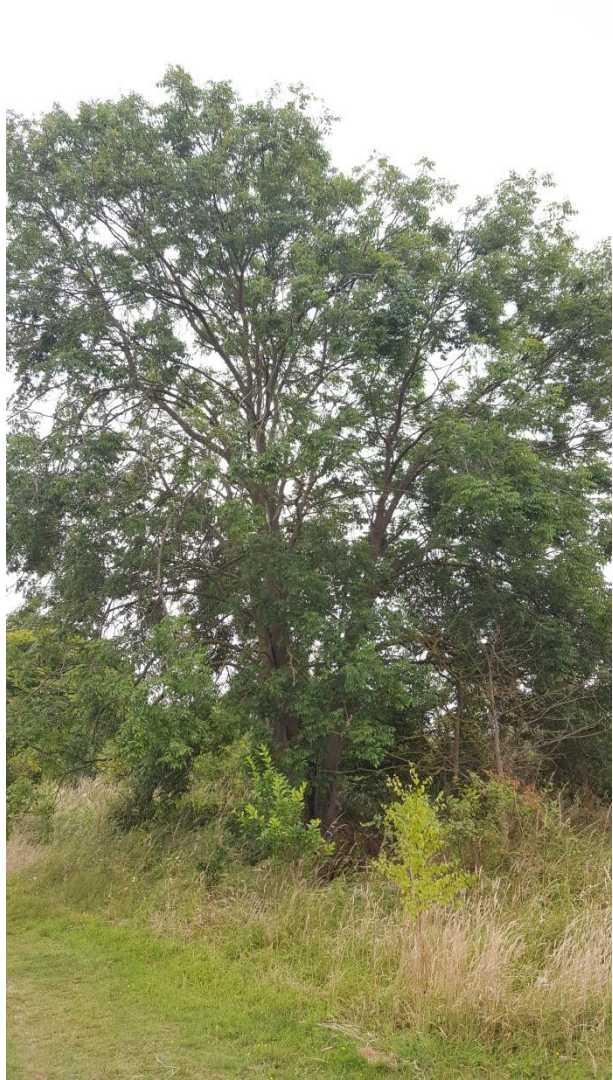
T8. Ash with a basal cavity that requires monitoring.

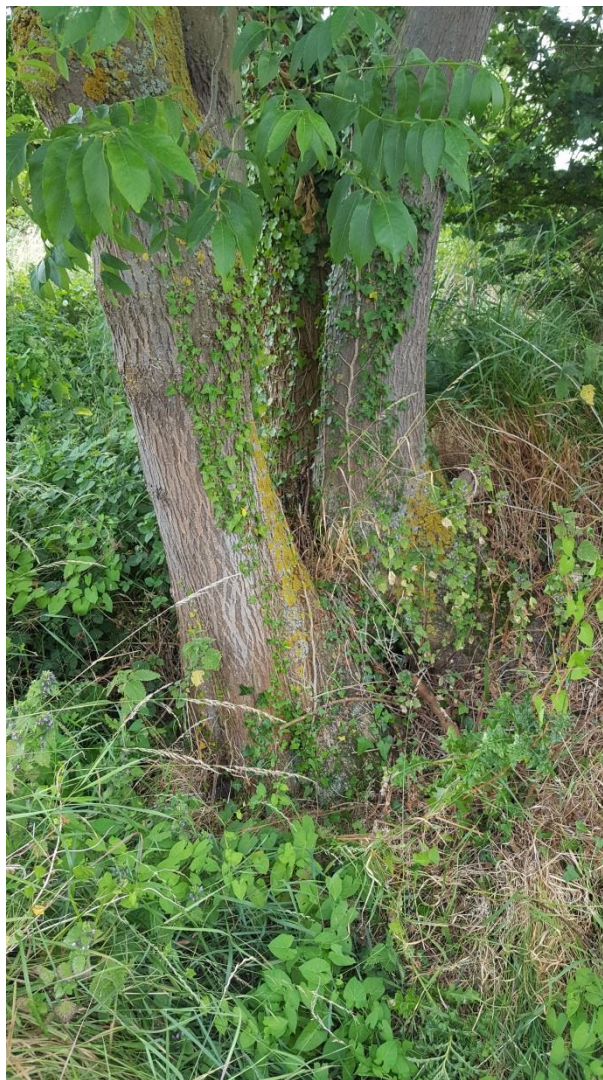
T8. Basal cavity.
