the **play inspection** company

Annual Inspection

Rochford District Council

Barling Play Space

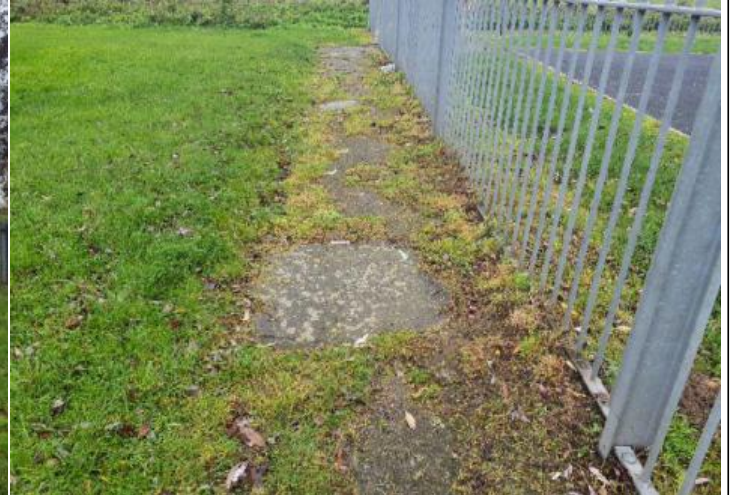
Item: Ancillary Items - Site General
Manufacturer: Owner/Operator

Finding: There is weed / vegetation growth within the surface

Action: Remove weed / vegetation growth

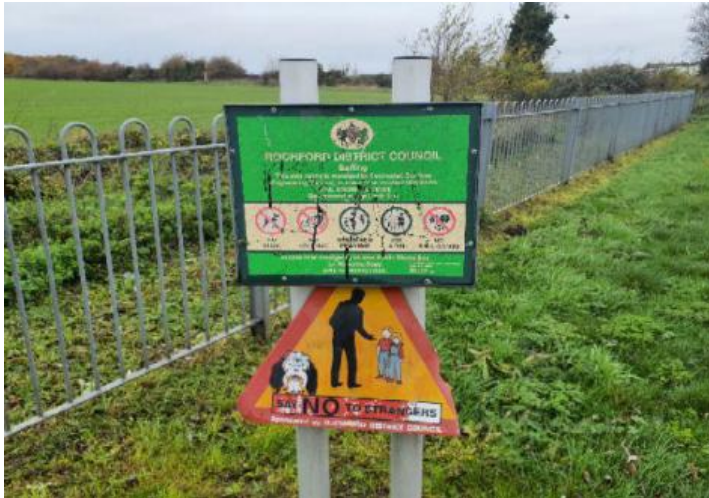
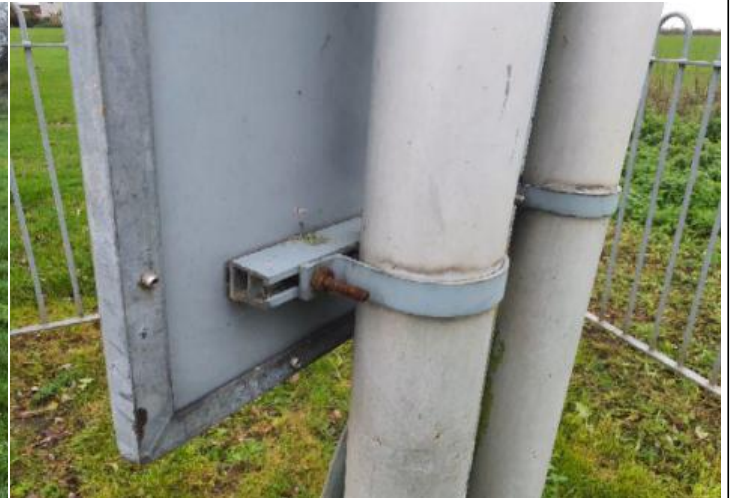
Item: Ancillary Items - Sign
Manufacturer: Not Identified

Finding: There are projecting bolt thread(s) present

Action: Remove excess thread length and deburr or provide cap

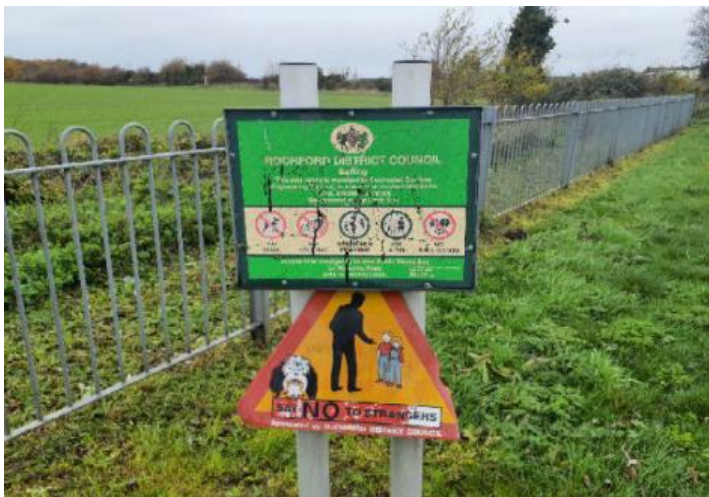
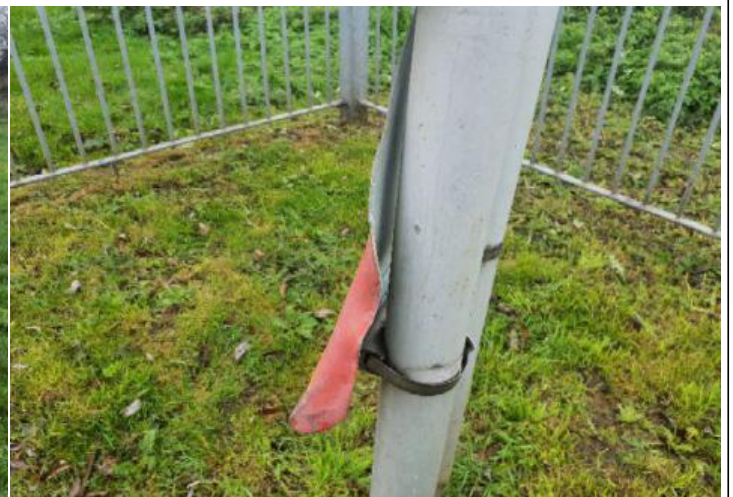
Item: Ancillary Items - Sign
Manufacturer: Not Identified

Finding: The item has been severely damaged

Action: Repair or replace the item / affected part

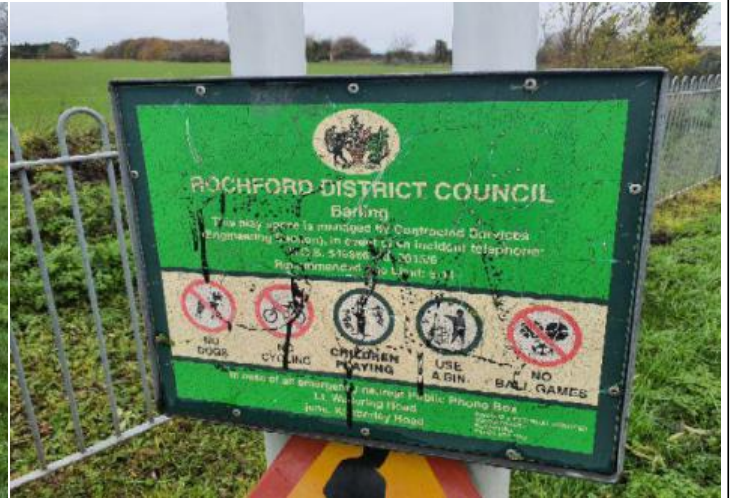
Item: Ancillary Items - Sign
Manufacturer: Not Identified

Finding: There is some graffiti present

Action: Remove the graffiti

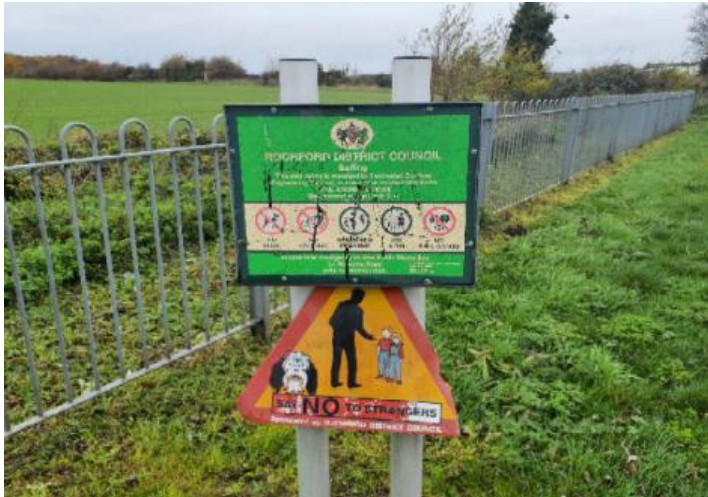
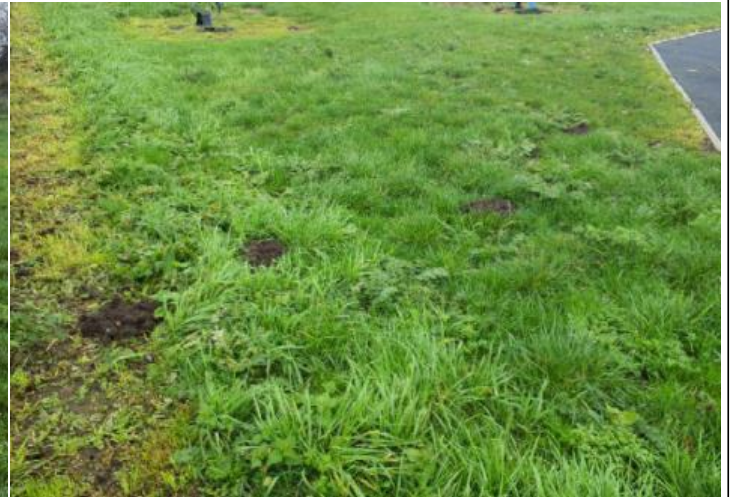
Item: Ancillary Items - Sign
Manufacturer: Not Identified

Finding: There are a number of molehills within the area and these may present unforeseen hazards for users

Action: Remove moles by appropriate means, reinstate surfaces to level and maintain the area

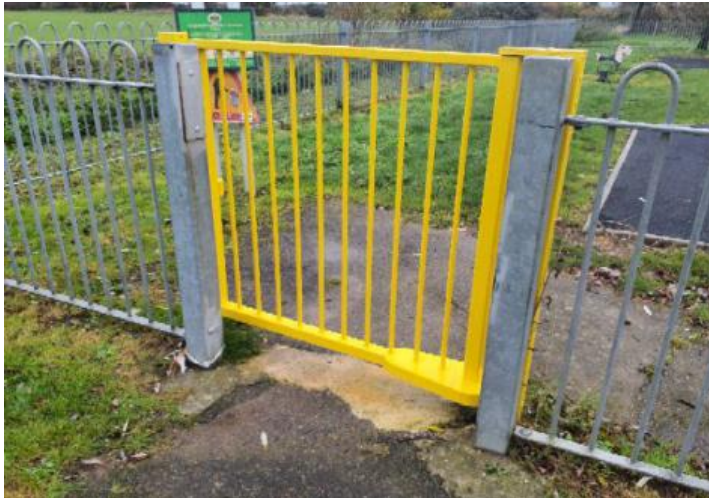
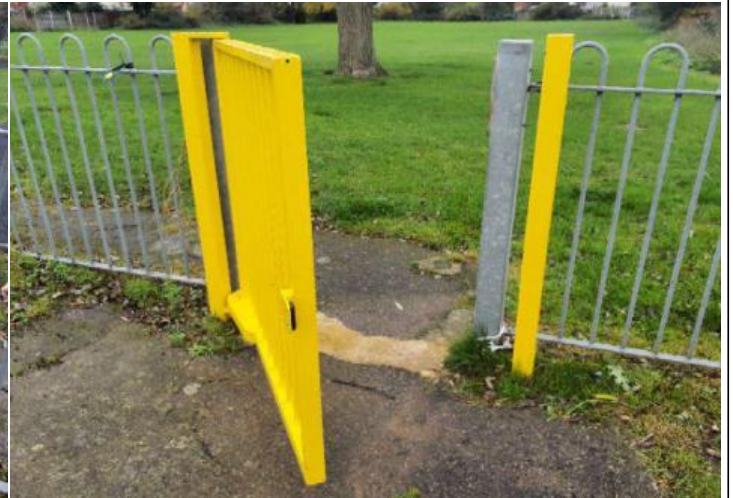
Item: Gates - Gate - Self Closing
Manufacturer: I.A.E. Fencing

Finding: The gate is not operating correctly

Action: Take effective action to ensure the gate closes between 4 and 8 seconds

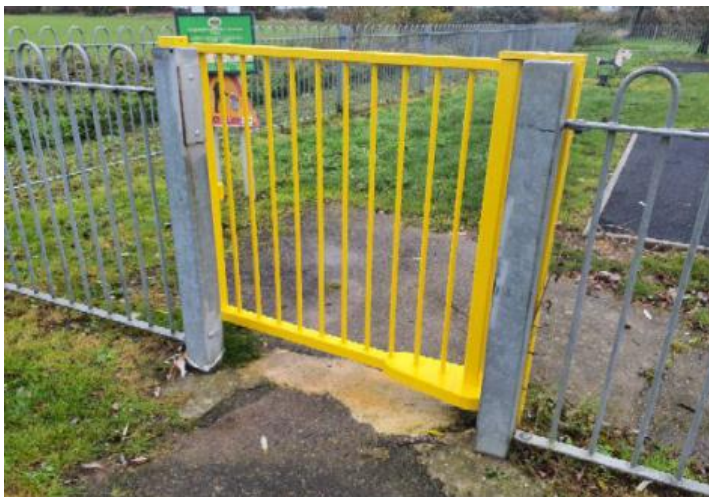
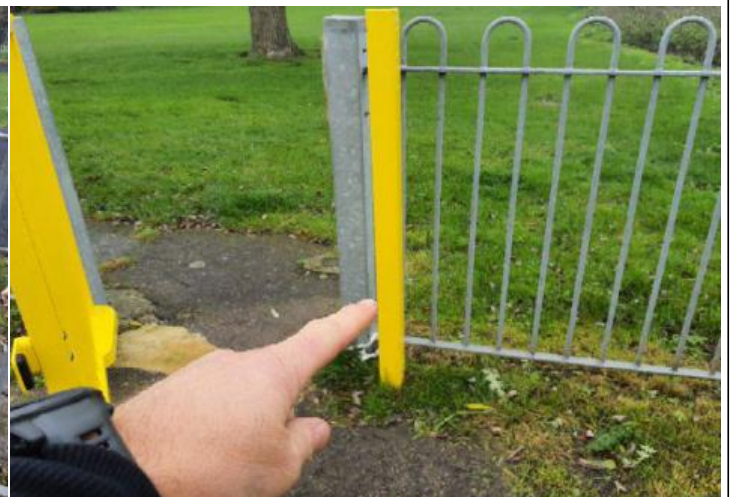
Item: Gates - Gate - Self Closing
Manufacturer: I.A.E. Fencing

Finding: The item is slightly loose in its foundations

Action: Monitor for any further deterioration and repair as required

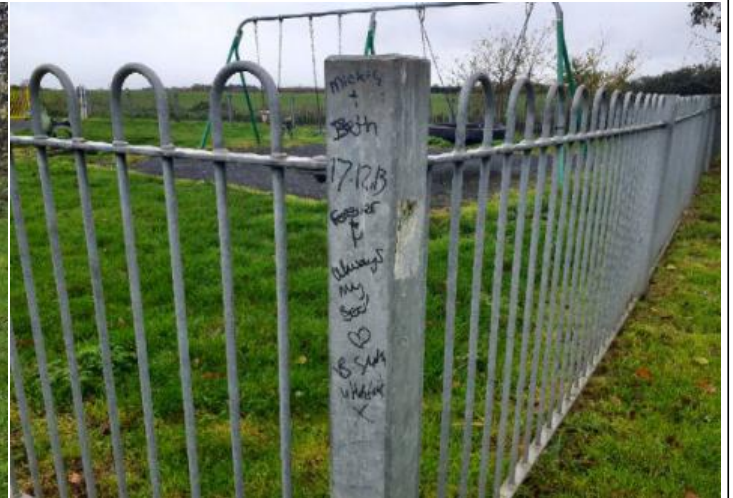
Item: Fences - Fence - Bow Top
Manufacturer: Not Identified

Finding: There is some graffiti present

Action: Remove the graffiti

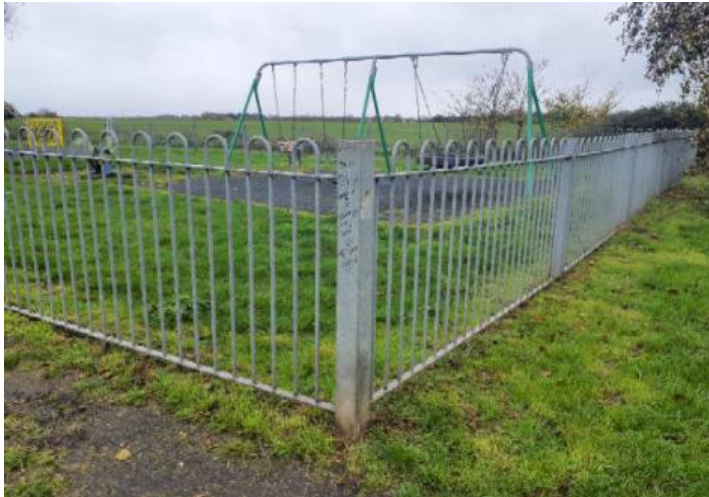
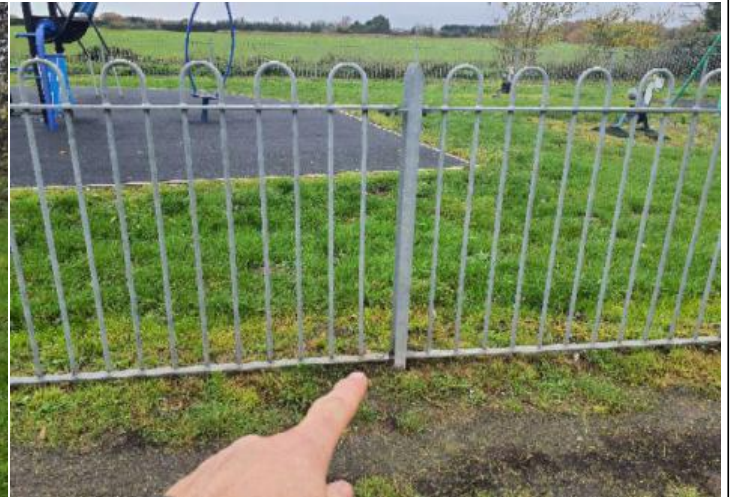
Item: Fences - Fence - Bow Top
Manufacturer: Not Identified

Finding: A number of fixing(s) have worked loose

Action: Secure all loose fixings

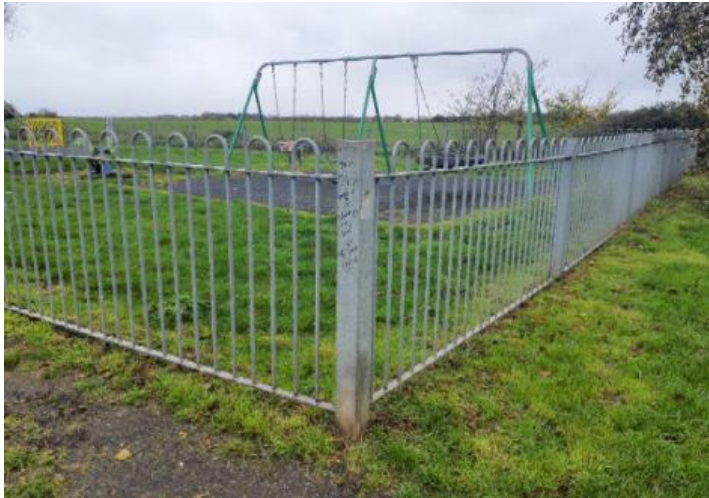
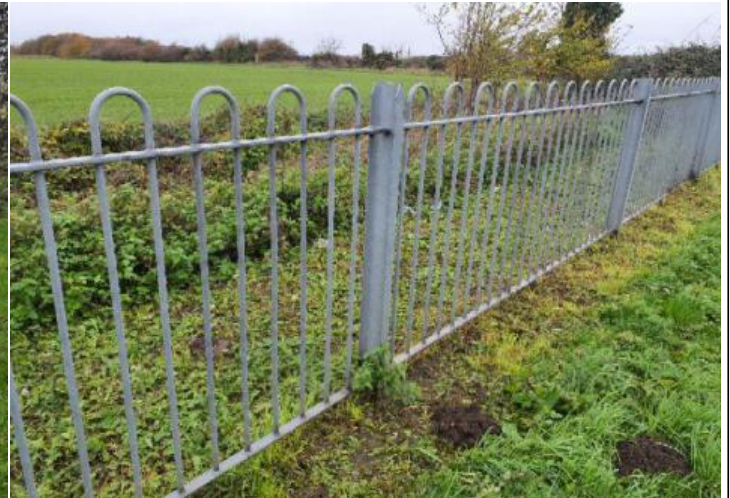
Item: Fences - Fence - Bow Top
Manufacturer: Not Identified

Finding: There are a number of loose posts around the fence

Action: Monitor for any further deterioration and reset as required

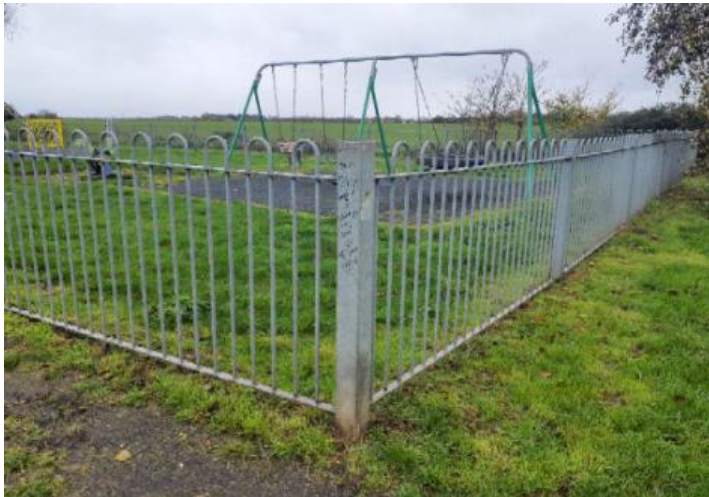
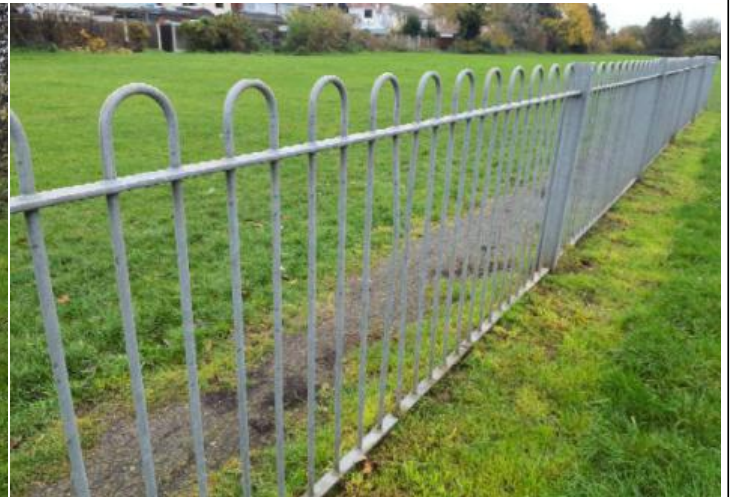
Item: Fences - Fence - Bow Top
Manufacturer: Not Identified

Finding: There is some damage to the fence sections

Action: Monitor for any further deterioration and repair as required

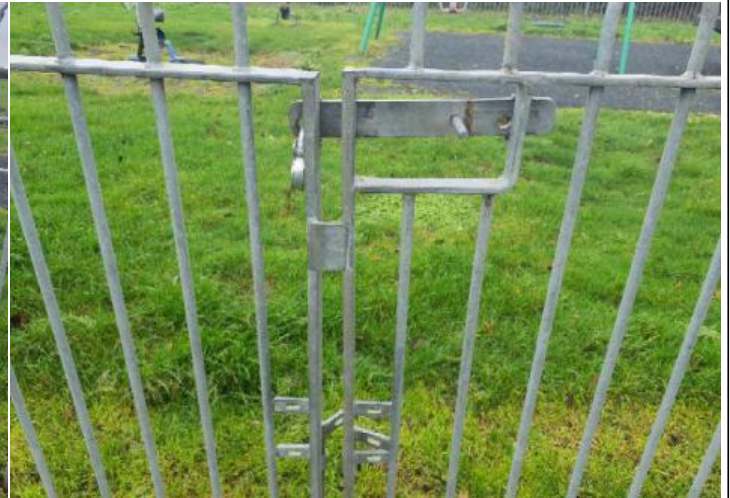
Item: Gates - Gate - Maintenance
Manufacturer: Not Identified

Finding: The maintenance gate was correctly padlocked at the time of inspection, however this means that the inspector was unable to fully assess the gate

Action: Ensure that there are 12mm gaps throughout the full range of motion on gate/s and between leaves where relevant

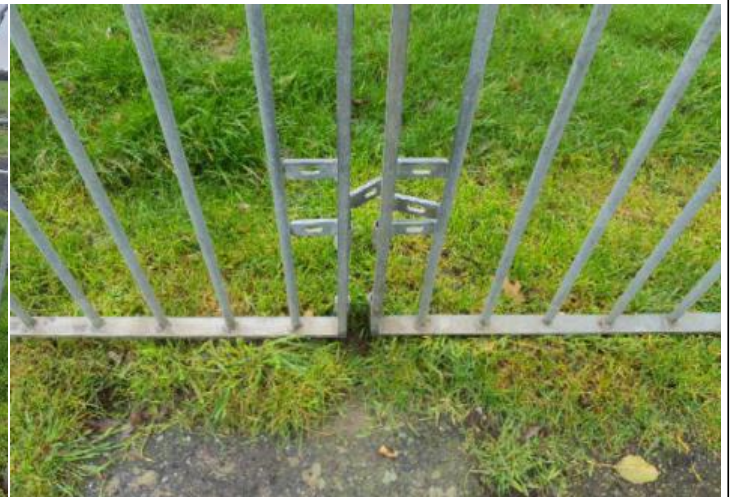
Item: Gates - Gate - Maintenance
Manufacturer: Not Identified

Finding: The gate has no drop bolt sleeves and/or drop bolts fitted

Action: Provide drop bolt sleeves and/or drop bolts

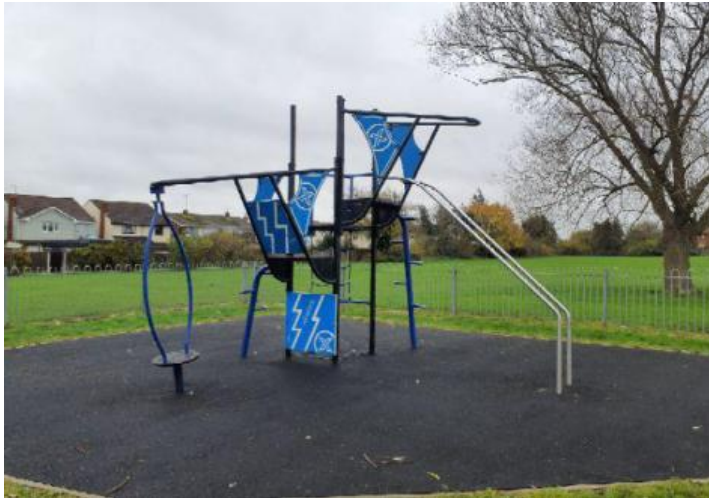
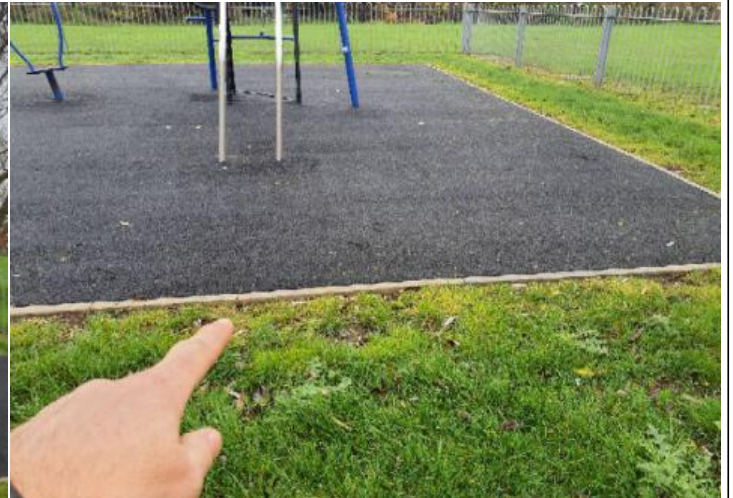
Item: Activity Equipment - Multi Play (Senior)
Manufacturer: Wicksteed Playgrounds

Finding: There are trip hazards at the edges of the surface **Action:** Remove trip hazard

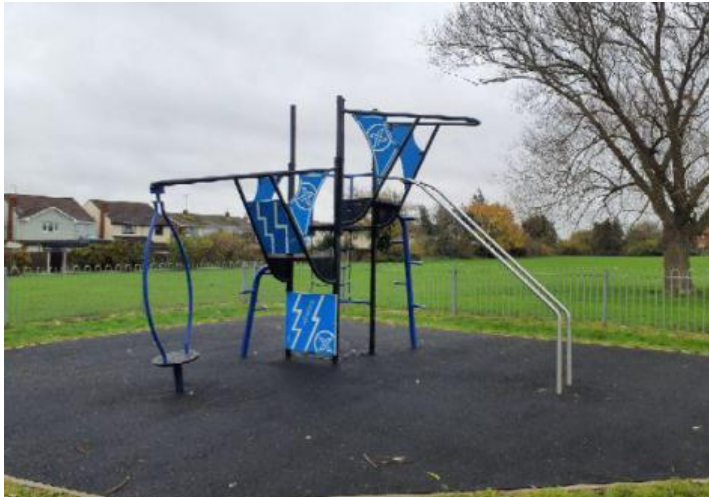
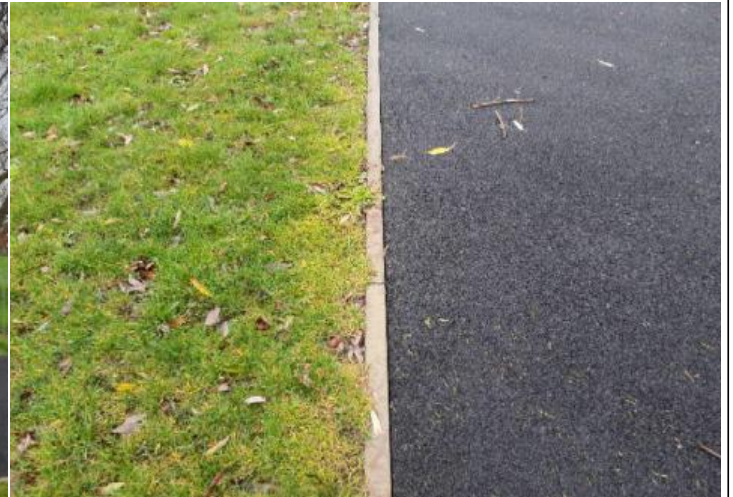
Item: Activity Equipment - Multi Play (Senior)
Manufacturer: Wicksteed Playgrounds

Finding: There are gaps opening between the surfacing and the edging surround or between the joints in the surfacing **Action:** Monitor for any further deterioration and repair as required

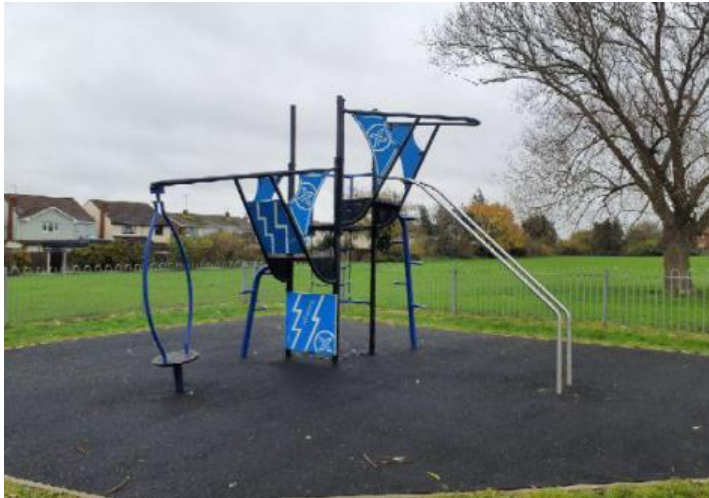
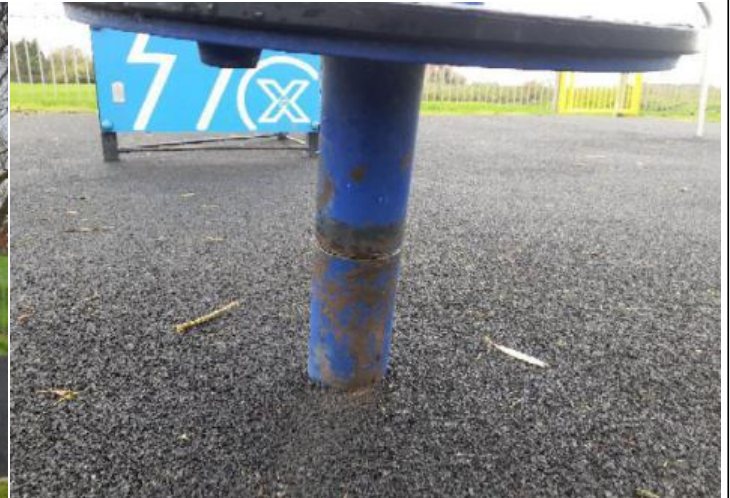
Item: Activity Equipment - Multi Play (Senior)
Manufacturer: Wicksteed Playgrounds

Finding: The bearing is showing signs of wear

Action: Monitor for any further deterioration and replace as required

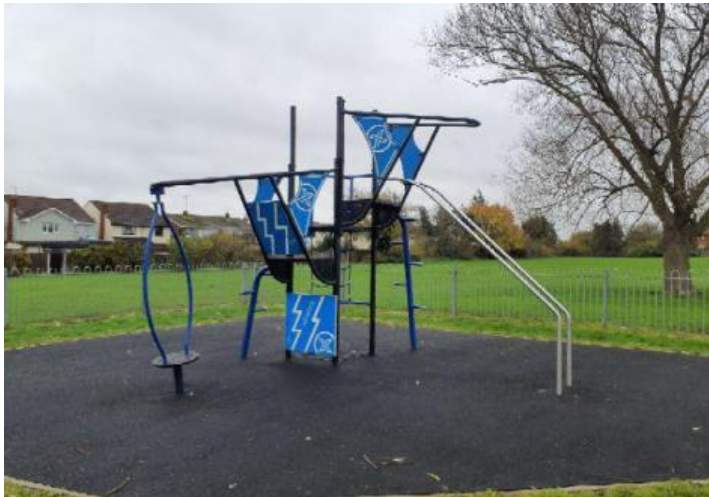
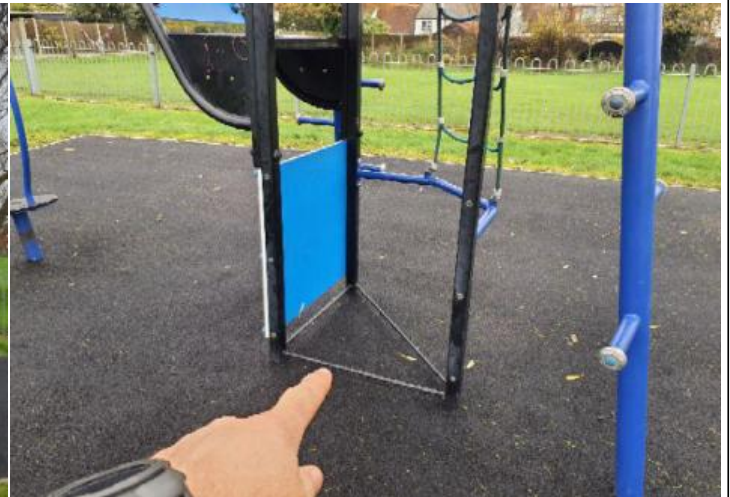
Item: Activity Equipment - Multi Play (Senior)
Manufacturer: Wicksteed Playgrounds

Finding: The lower frame forms a projecting obstacle / hard object within the falling space of the equipment, in contravention of the requirements of BS EN 1176 Part 1

Action: Monitor - No remedial work recommended

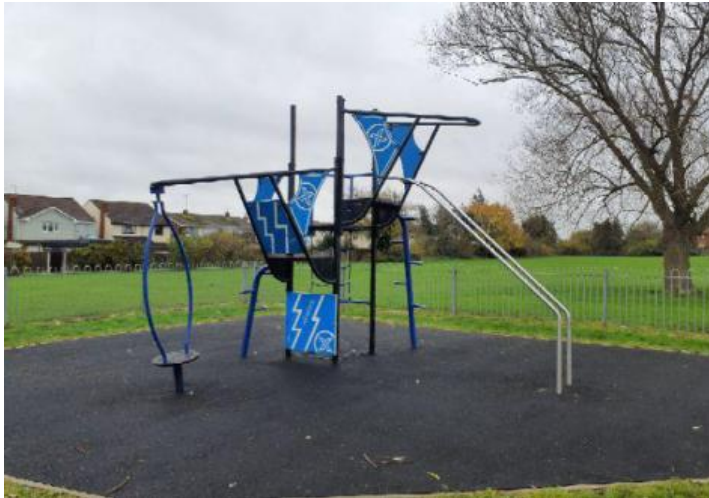
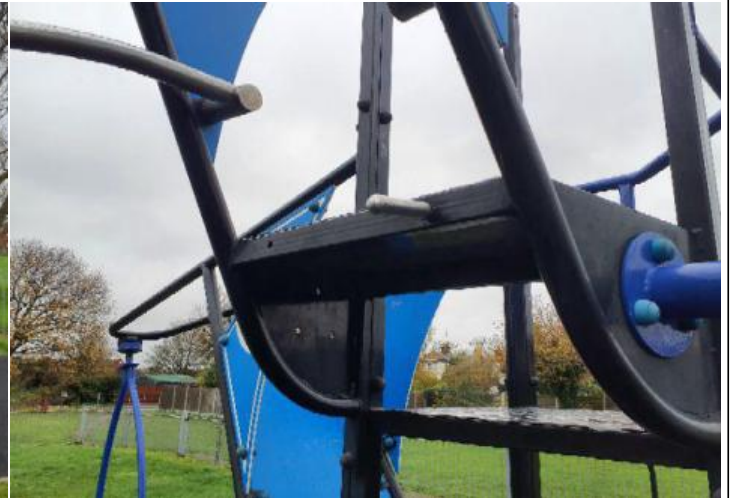
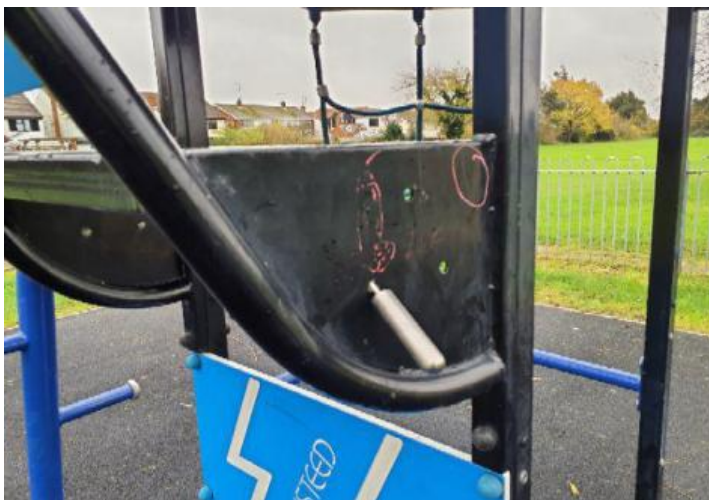
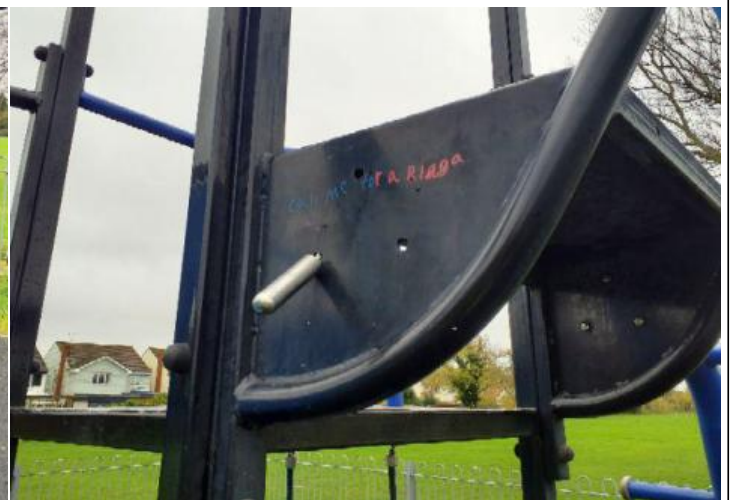
Item: Activity Equipment - Multi Play (Senior)
Manufacturer: Wicksteed Playgrounds

Finding: There is/are finger entrapment/s in the framework and the item fails to meet the requirements of BS EN 1176 Part 1 4.2.7.6 Entrapment of fingers

Action: Replace the missing insert to remove the entrapment

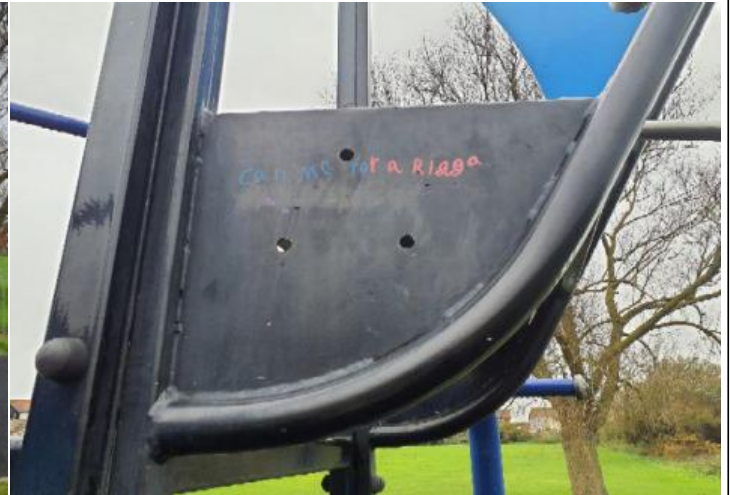
Item: Activity Equipment - Multi Play (Senior)
Manufacturer: Wicksteed Playgrounds

Finding: There is some graffiti present

Action: Remove the graffiti

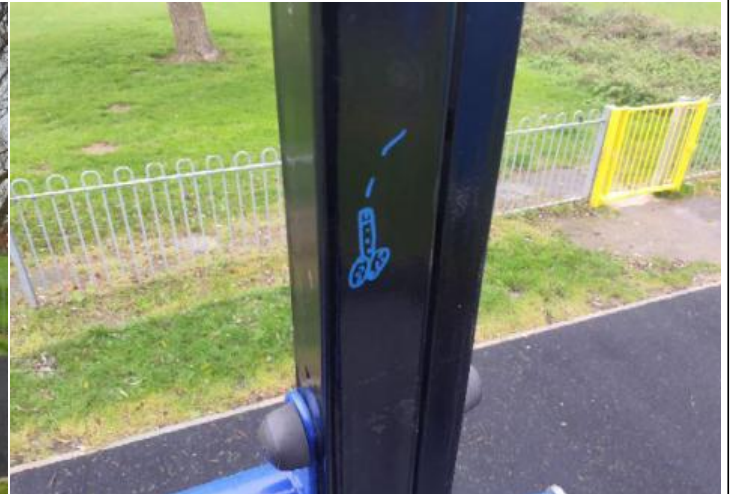
Item: Activity Equipment - Multi Play (Senior)
Manufacturer: Wicksteed Playgrounds

Finding: There is offensive graffiti present

Action: Remove as soon as practicable

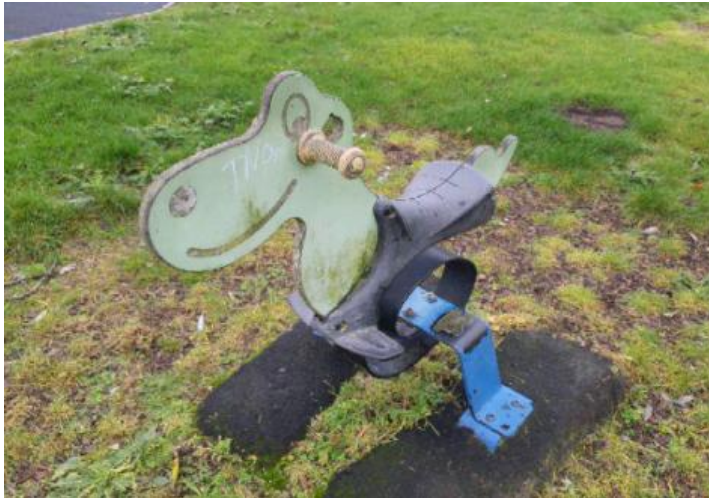
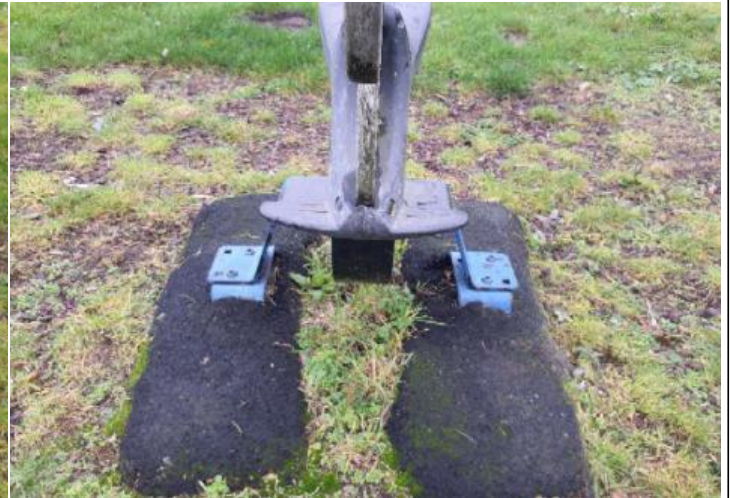
Item: Rocking Equipment - Spring Dino
Manufacturer: Lappset UK Ltd

Finding: The exposed anchoring under the item is more than 1.3 times the width of the seat, in contravention of the requirements of BS EN 1176 Part 6

Action: Monitor - no remedial work recommended

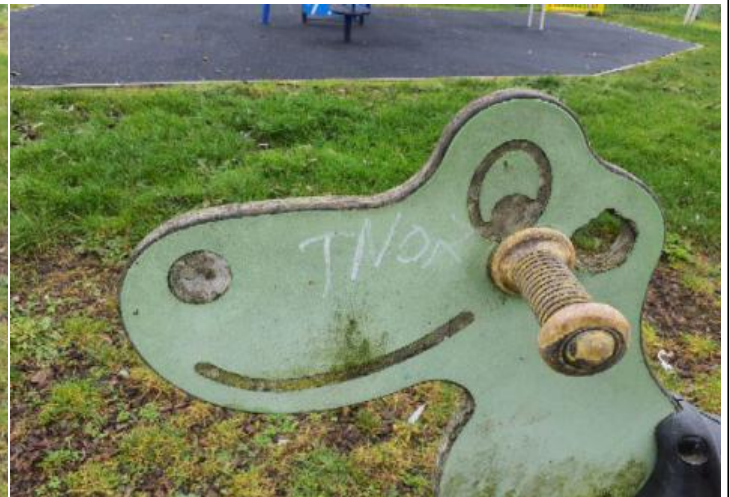
Item: Rocking Equipment - Spring Dino
Manufacturer: Lappset UK Ltd

Finding: There is some graffiti present

Action: Remove the graffiti

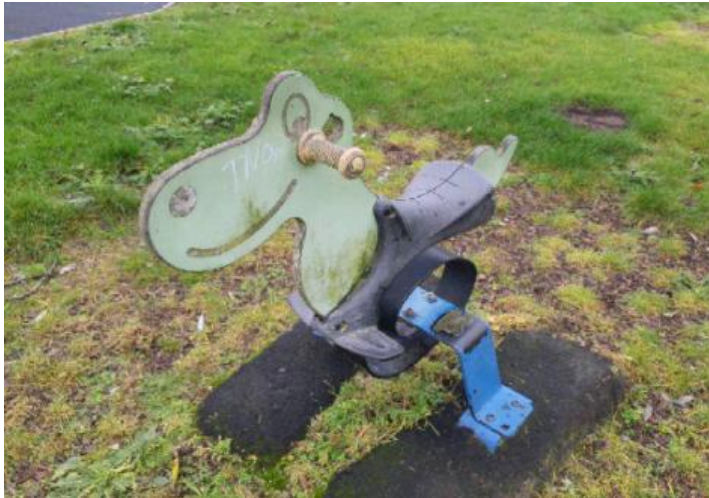
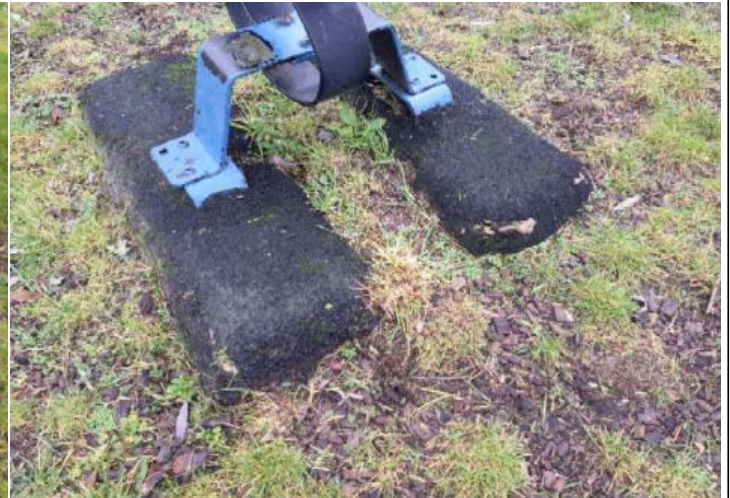
Item: Rocking Equipment - Spring Dino
Manufacturer: Lappset UK Ltd

Finding: There is moderate damage to the surface

Action: Repair the damaged areas of surfacing

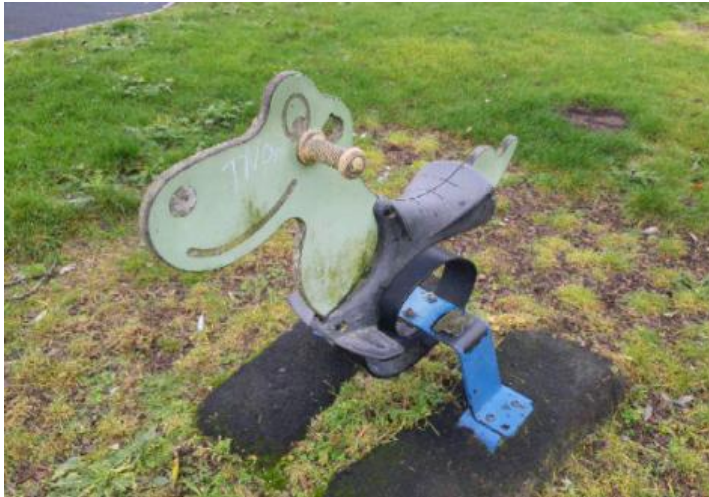
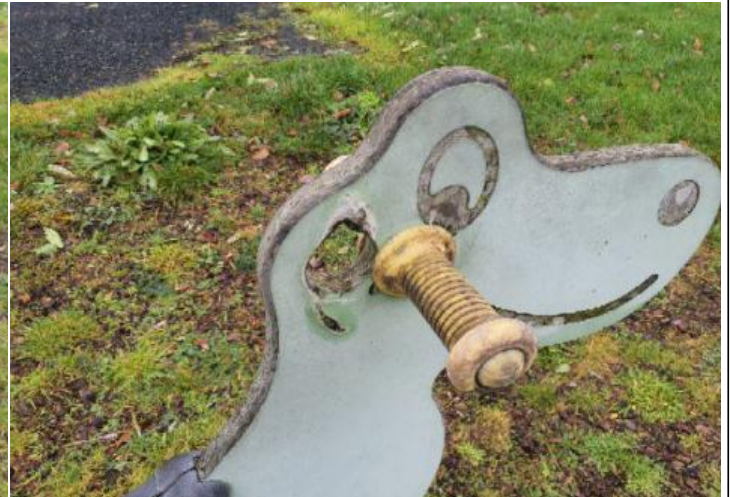
Item: Rocking Equipment - Spring Dino
Manufacturer: Lappset UK Ltd

Finding: The item has been damaged

Action: Monitor for any further deterioration and replace as required

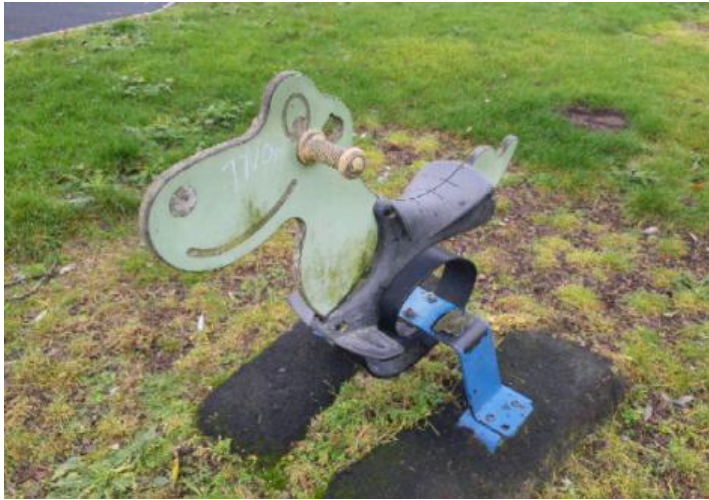
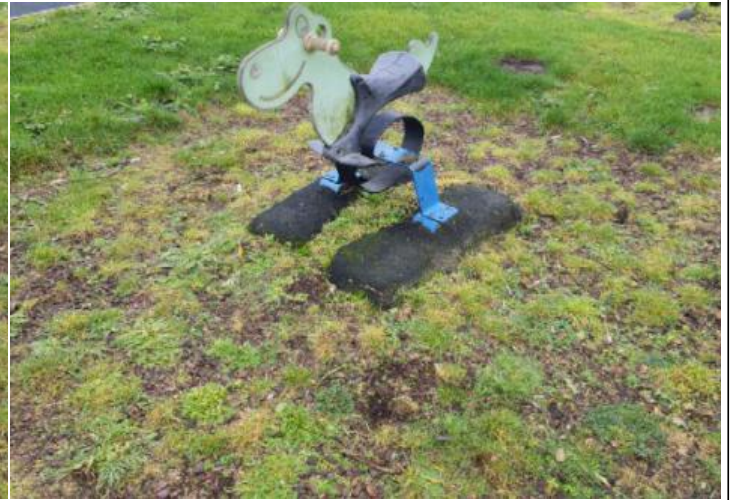
Item: Rocking Equipment - Spring Dino
Manufacturer: Lappset UK Ltd

Finding: The depth of the loose fill surfacing is lower than the recommended depth specified in BS EN 1176; the free height of fall of the equipment is less than 2.0m and a minimum of 300mm depth should be provided (including an extra 100mm to allow for compaction and displacement as per BS EN 1176 Part 1 - Table 4)

Action: Top up loose fill surfacing to recommended levels

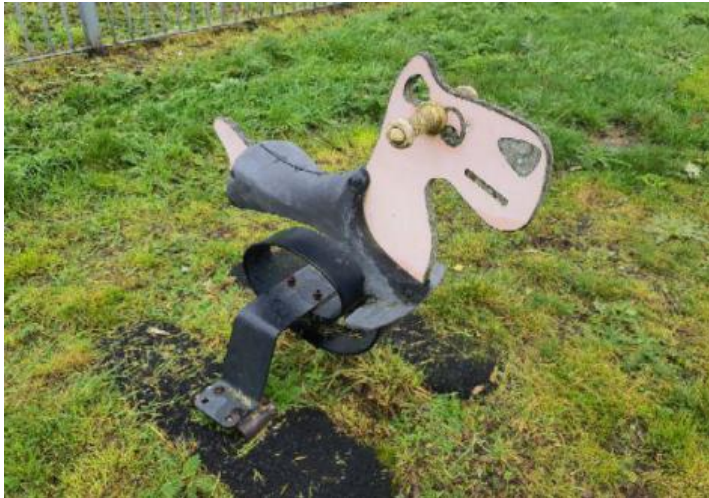
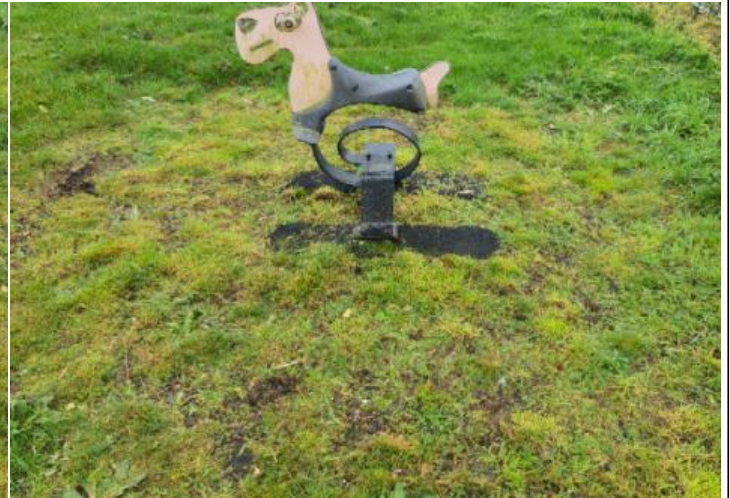
Item: Rocking Equipment - Spring Dog
Manufacturer: Lappset UK Ltd

Finding: The depth of the loose fill surfacing is lower than the recommended depth specified in BS EN 1176; the free height of fall of the equipment is less than 2.0m and a minimum of 300mm depth should be provided (including an extra 100mm to allow for compaction and displacement as per BS EN 1176 Part 1 - Table 4)

Action: Top up loose fill surfacing to recommended levels

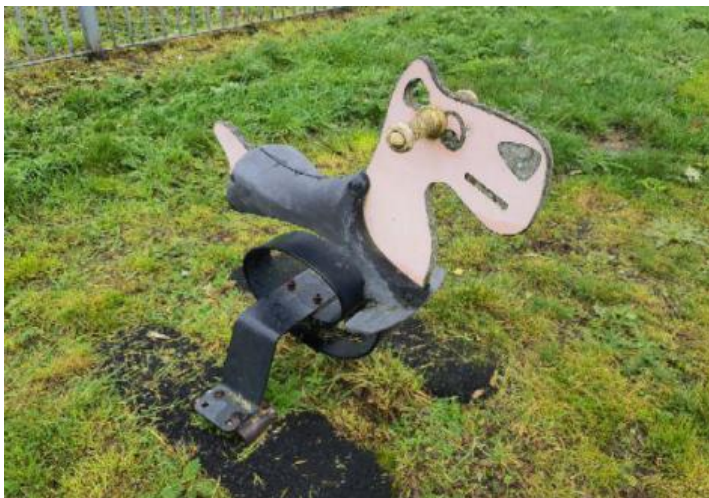
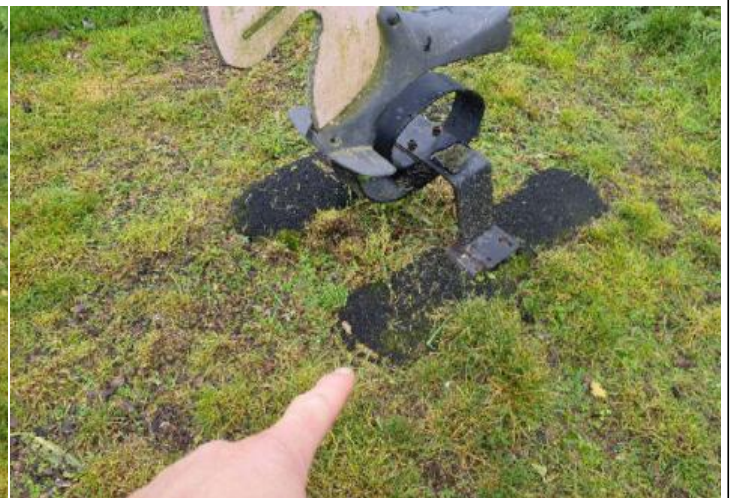
Item: Rocking Equipment - Spring Dog
Manufacturer: Lappset UK Ltd

Finding: There is moderate damage to the surface

Action: Repair the damaged areas of surfacing

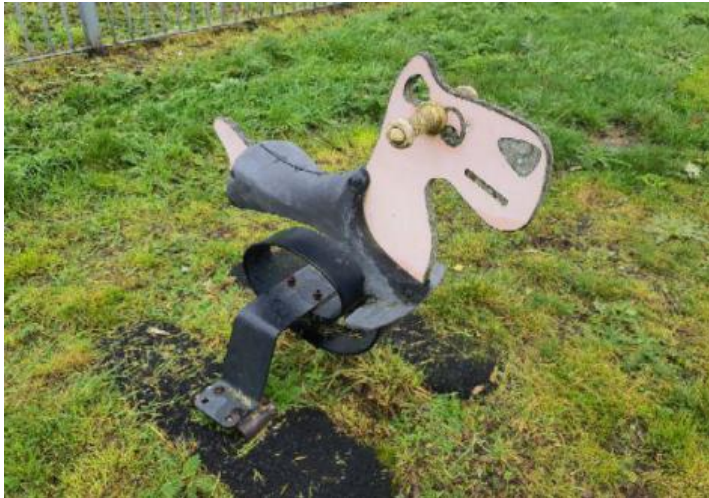
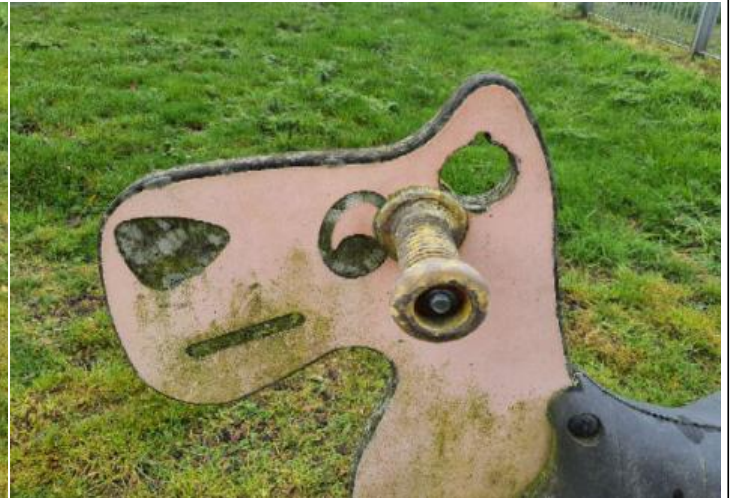
Item: Rocking Equipment - Spring Dog
Manufacturer: Lappset UK Ltd

Finding: There is/are bolt cap covers missing or damaged on the item

Action: Replace missing or damaged bolt cap covers

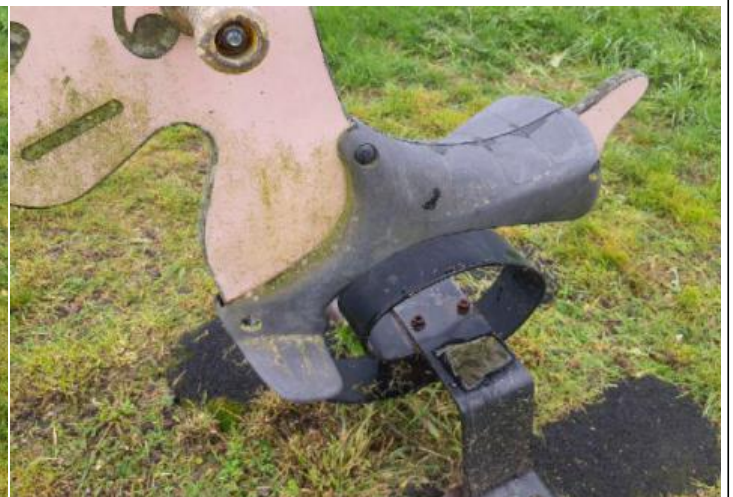
Item: Rocking Equipment - Spring Dog
Manufacturer: Lappset UK Ltd

Finding: There is algae or moss on the surface of the equipment

Action: Clean and treat appropriately

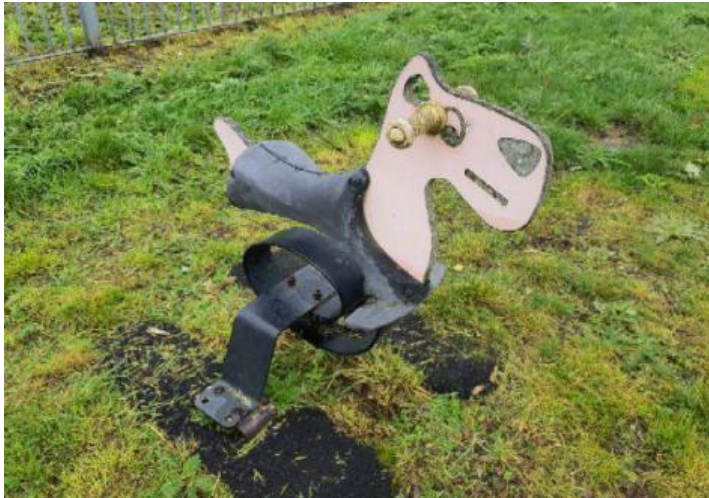
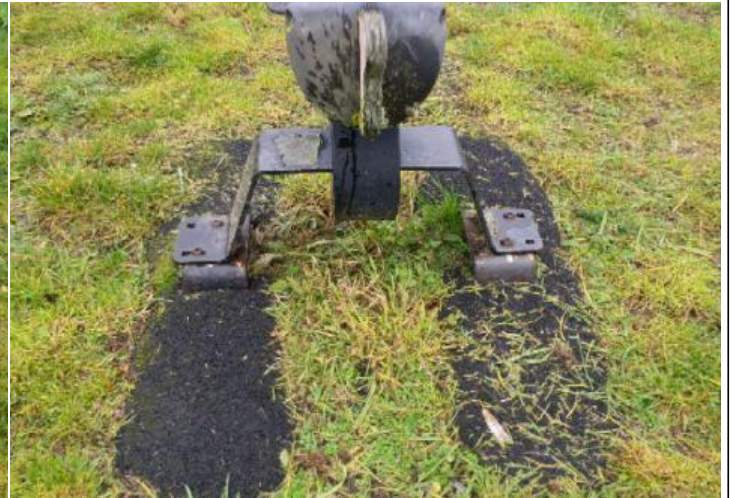
Item: Rocking Equipment - Spring Dog
Manufacturer: Lappset UK Ltd

Finding: The exposed anchoring under the item is more than 1.3 times the width of the seat, in contravention of the requirements of BS EN 1176 Part 6

Action: Monitor - no remedial work recommended

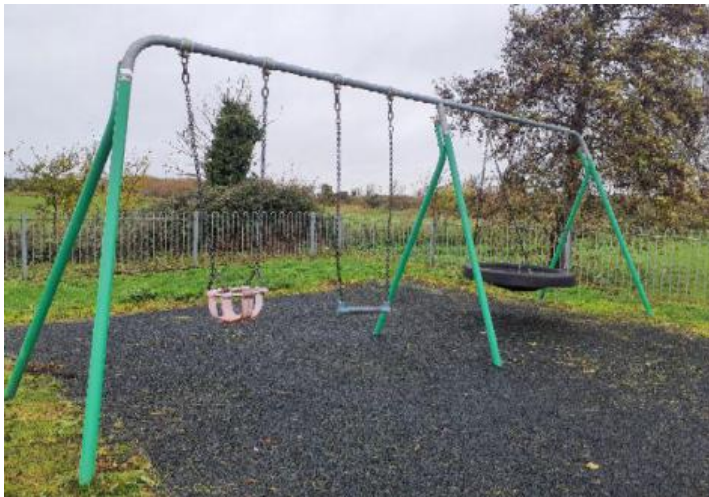
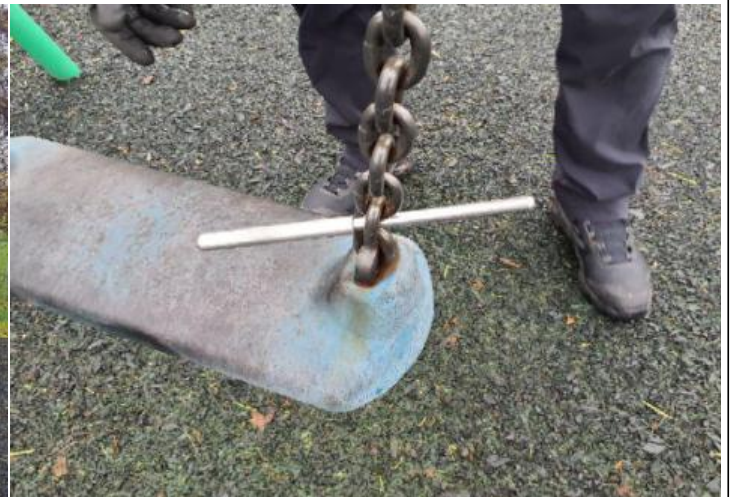
Finding: The chain openings are in excess of the 8.6mm as recommended by BS EN 1176

Action: Monitor - No action given the risk assessment

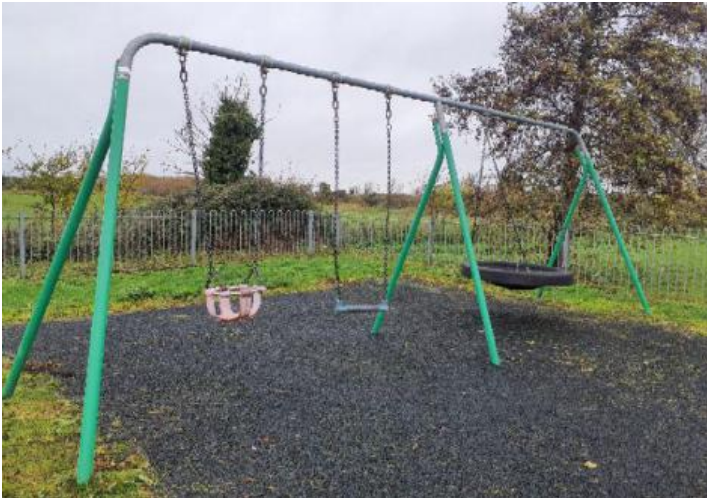
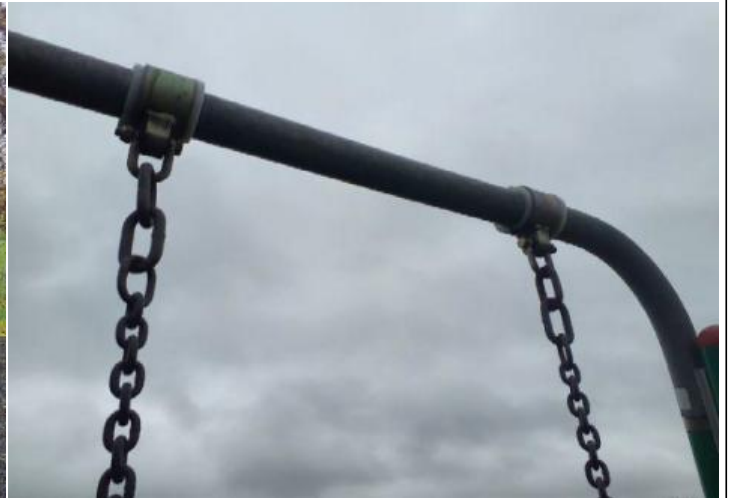
Finding: The shackles have been overtightened or seized transferring wear to the chain links below

Action: Loosen shackles to ensure free movement at the pivot

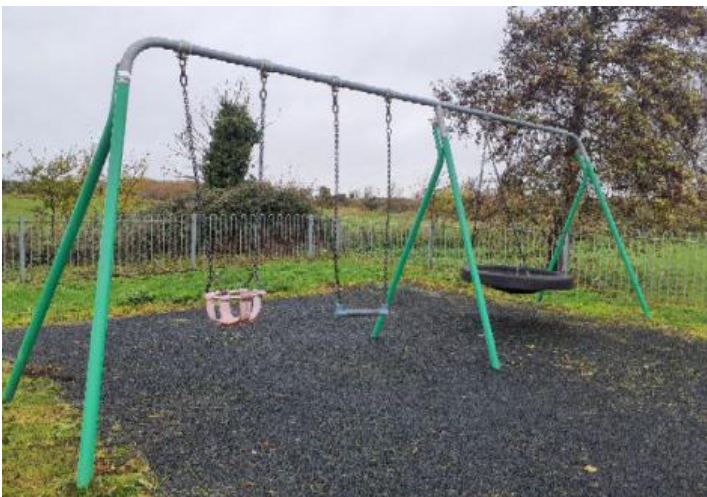
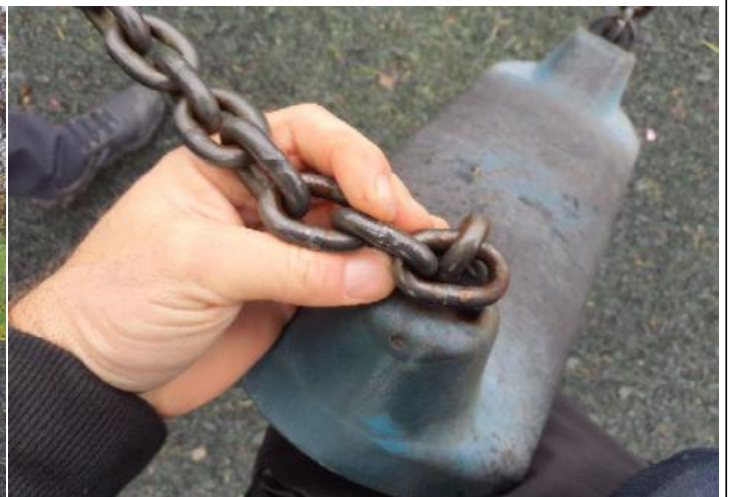
Finding: There is some notable evidence of chain wear

Action: Monitor for any further deterioration and replace when 40% worn
