the **play inspection** company

Annual Inspection

Rochford District Council

Barling Play Space

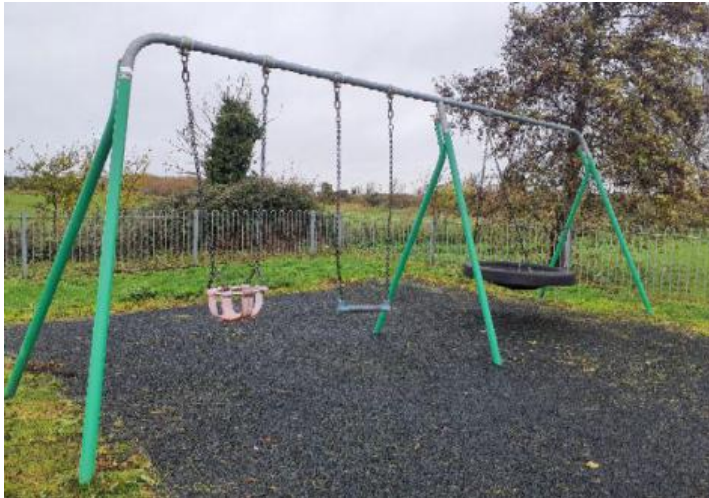
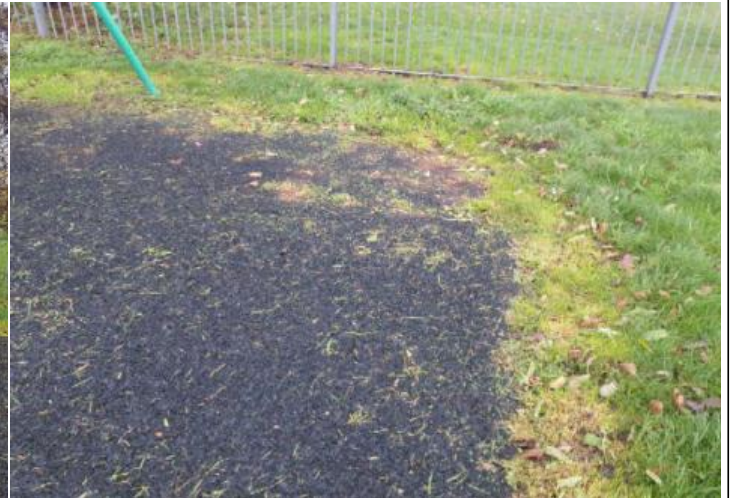
Finding: The surface has subsided in some areas

Action: Monitor for any further deterioration and repair as required

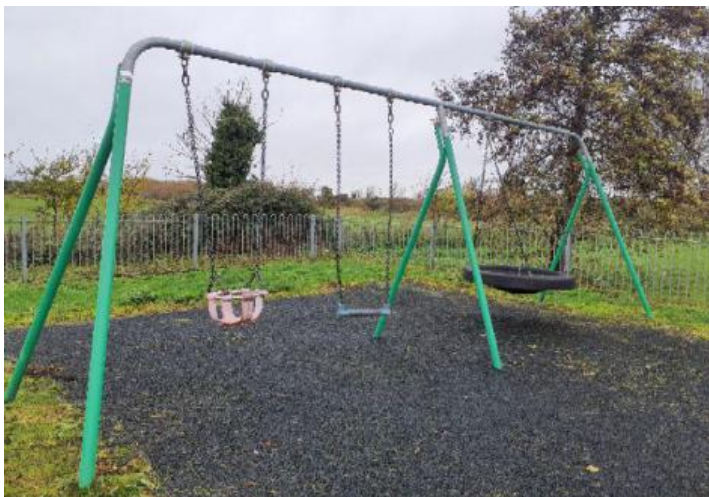
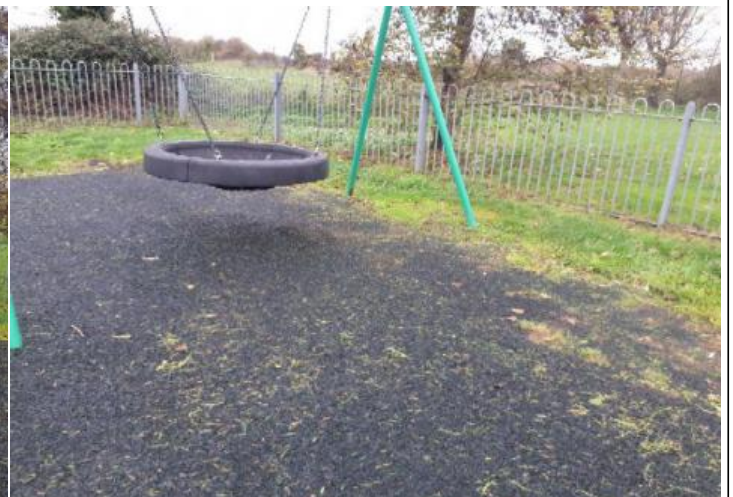
Finding: The surface has subsided in some areas

Action: Monitor for any further deterioration and repair as required

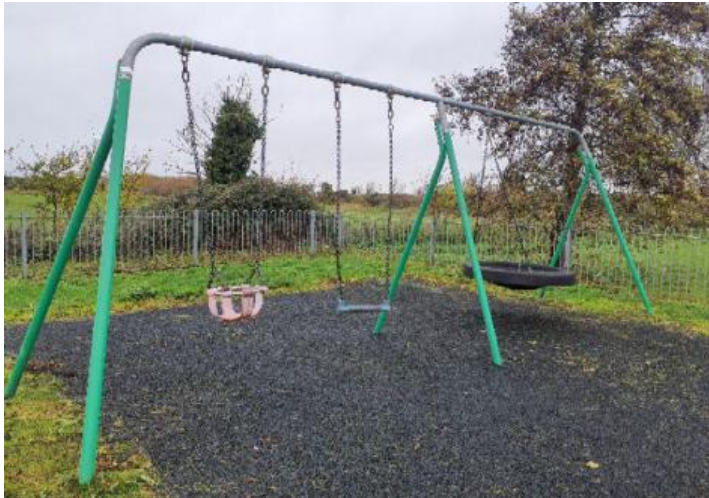
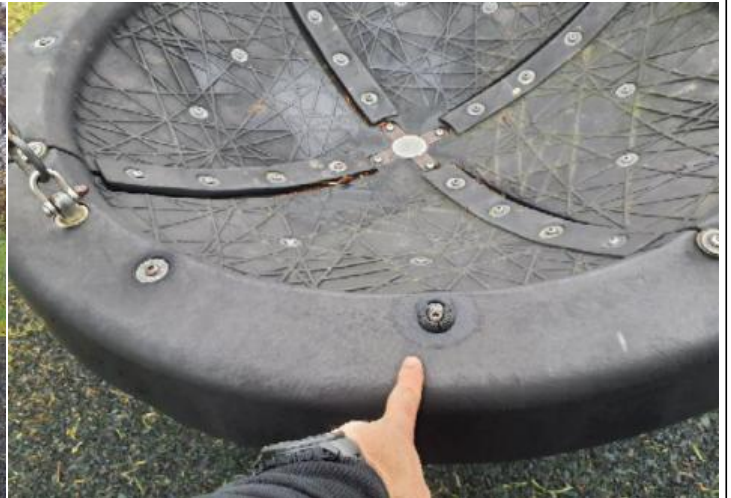
Finding: The seat has minor damage or wear

Action: Monitor for any further deterioration and replace as required
