the **play inspection** company

Annual Inspection

Rochford District Council

Barling Play Space

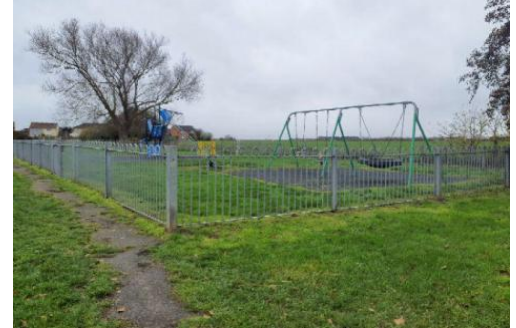
Item: Site General
Manufacturer: Owner/Operator
Surface Type: N/A
Item Quantity: 1
Equipment Compliance: N/A
Surface Area Compliance: N/A

There is weed / vegetation growth within the surface - Remove weed / vegetation growth

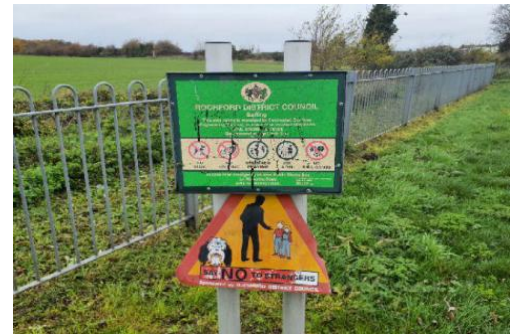
Item: Sign
Manufacturer: Not Identified
Surface Type: Grass
Item Quantity: 1
Equipment Compliance: N/A
Surface Area Compliance: N/A

There are projecting bolt thread(s) present - Remove excess thread length and deburr or provide cap

The item has been severely damaged - Repair or replace the item / affected part

There are a number of molehills within the area and these may present unforeseen hazards for users - Remove moles by appropriate means, reinstate surfaces to level and maintain the area

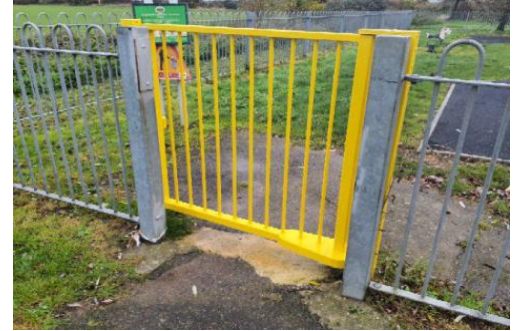
Item: Gate - Self Closing
Manufacturer: I.A.E. Fencing
Surface Type: Bitmac
Item Quantity: 1
Equipment Compliance: N/A
Surface Area Compliance: N/A

The item is slightly loose in its foundations - Monitor for any further deterioration and repair as required

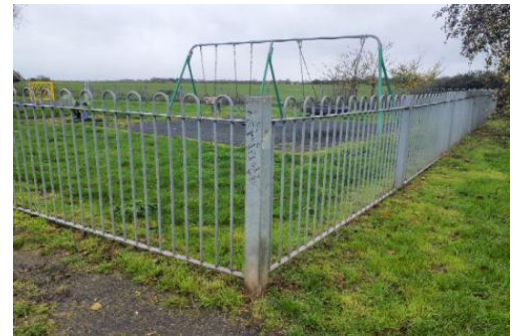
Item: Fence - Bow Top
Manufacturer: Not Identified
Surface Type: Grass
Item Quantity: 1
Equipment Compliance: N/A
Surface Area Compliance: N/A

A number of fixing(s) have worked loose - Secure all loose fixings

There are a number of loose posts around the fence - Monitor for any further deterioration and reset as required

There is some damage to the fence sections - Monitor for any further deterioration and repair as required

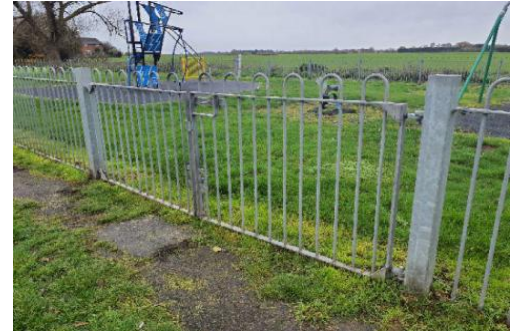
Item: Gate - Maintenance
Manufacturer: Not Identified
Surface Type: Grass
Item Quantity: 1
Equipment Compliance: N/A
Surface Area Compliance: N/A

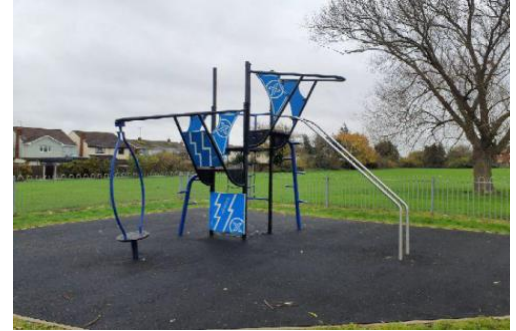
Item: Multi Play (Senior)
Manufacturer: Wicksteed Playgrounds
Surface Type: Wet Pour
Item Quantity: 1
Equipment Compliance: No
Surface Area Compliance: Yes
Life Expectancy: >10 Years
Total Findings: 7

There are trip hazards at the edges of the surface - Remove trip hazard

There are gaps opening between the surfacing and the edging surround or between the joints in the surfacing - Monitor for any further deterioration and repair as required

The bearing is showing signs of wear - Monitor for any further deterioration and replace as required

The lower frame forms a projecting obstacle / hard object within the falling space of the equipment, in contravention of the requirements of BS EN 1176 Part 1 - Monitor - No remedial work recommended

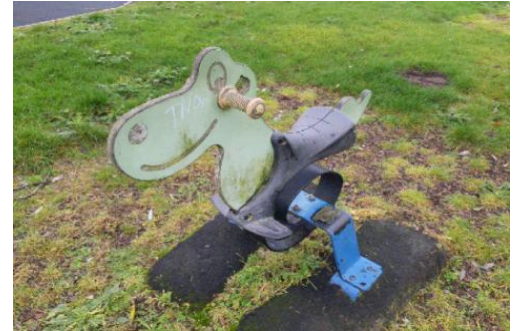
Item: Spring Dino
Manufacturer: Lappset UK Ltd
Surface Type: Bark Mulch
Item Quantity: 1
Equipment Compliance: No
Surface Area Compliance: Yes
Life Expectancy: 3 - 5 Years
Total Findings: 5

The exposed anchoring under the item is more than 1.3 times the width of the seat, in contravention of the requirements of BS EN 1176 Part 6 - Monitor - no remedial work recommended

There is moderate damage to the surface - Repair the damaged areas of surfacing

The item has been damaged - Monitor for any further deterioration and replace as required

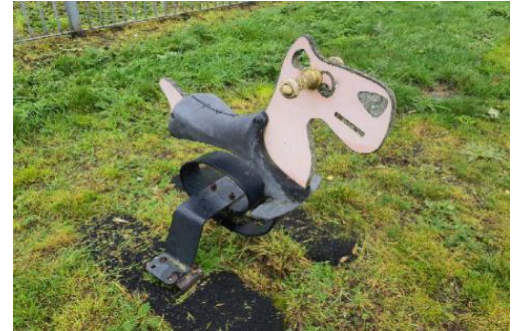
Item: Spring Dog
Manufacturer: Lappset UK Ltd
Surface Type: Bark Mulch
Item Quantity: 1
Equipment Compliance: No
Surface Area Compliance: Yes
Life Expectancy: 3 - 5 Years
Total Findings: 5

The depth of the loose fill surfacing is lower than the recommended depth specified in BS EN 1176; the free height of fall of the equipment is less than 2.0m and a minimum of 300mm depth should be provided (including an extra 100mm to allow for compaction and displacement as per BS EN 1176 Part 1 - Table 4) - Top up loose fill surfacing to recommended levels

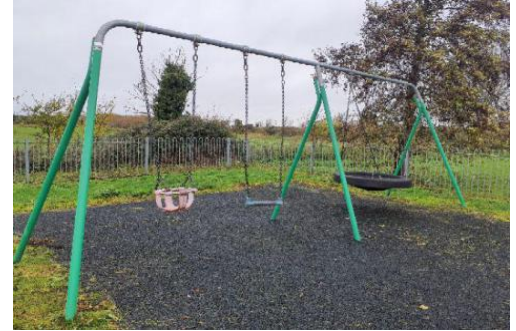
Item: 2 Bay Swing
Manufacturer: Sutcliffe Play Limited
Surface Type: Bonded Rubber Mulch
Item Quantity: 1
Equipment Compliance: No
Surface Area Compliance: Yes
Life Expectancy: 5 -10 Years
Total Findings: 6

The chain openings are in excess of the 8.6mm as recommended by BS EN 1176 - Monitor - No action given the risk assessment
